Slocan River
Preliminary Side Channel Assessment: 2010

Peter J. Corbett, RPBio
Mirkwood Ecological Consultants Ltd.
P.O. Box 138
Winlaw, B.C. V0G 2J0

February, 2011

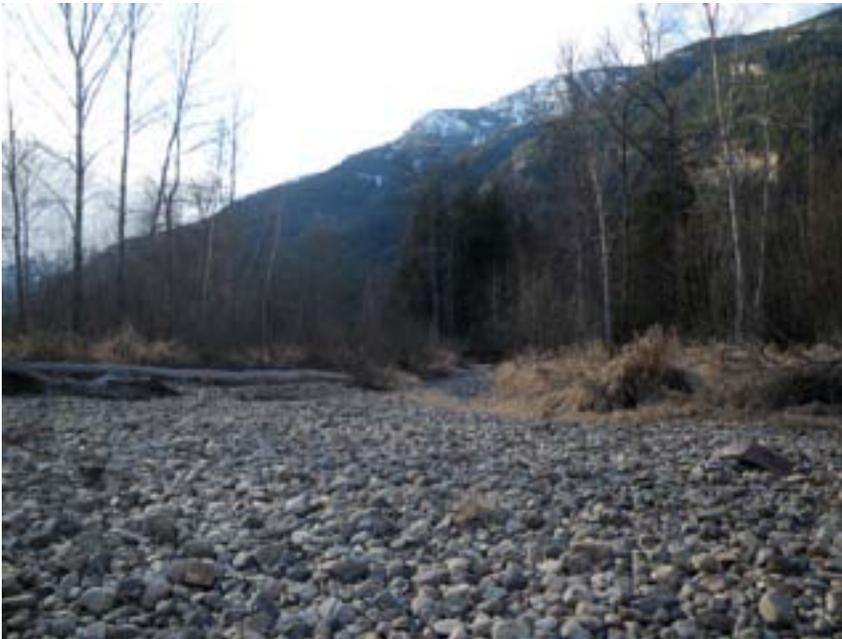
Figure 8. Lower Lemon channel (1-1) looking downstream.

The Lower Lemon side channels begins as a single cobble opening and then braids into several channels before merging as a single channel again at its terminus. It is

approximately 900 m long. There appears to be a cold-water spring entering the channel 300 m up from the downstream end ensuring that there is always water in its lower reaches. There are potentially 10+ good pools with good stream cover throughout. Unlike many of the other side channels on the Slocan River, this channel does not lose stream gradient for the bottom half of its length but remains steep enough to provide trout habitat along its entire length. There are portions of the channel dominated by gravel and would likely provide spawning opportunity.

The channel opening is within approximately 300 m from the small road leading to the Lemon Pool. Removal of cobbles would be required. This could be facilitated by hand removal or machine.

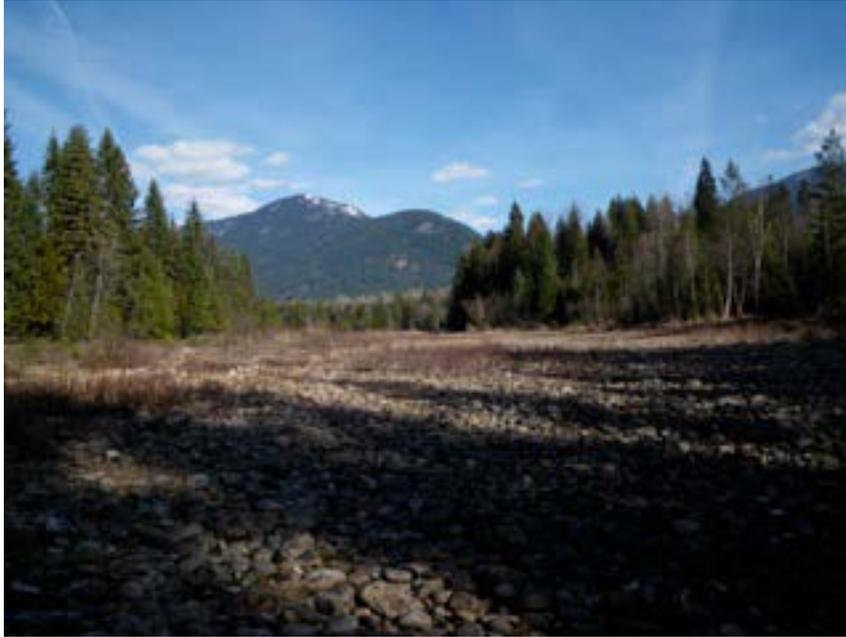
Figure 9. TNT channel (1-2) looking up stream towards channel mouth.

This is the longest side channel on the river and is separated from the mainstem by Nixon's Island that The Nature Trust has just recently purchased. In the 90's this was the mainstem of the river. The bottom half of the channel loses gradient and provides little trout habitat. The upper half provides excellent trout habitat but will require a significant amount of discharge to once gain provide habitat. There are approximately 7 pools with potential to provide good habitat for trout. There are also a significant number of gravel sites that could provide for spawning opportunities.

There is a large volume of cobbles and boulders that would require removal to establish this channel once again. A machine would likely be need. Access would best be from the other side of the river through the Larsen property and would require crossing the river during low water.

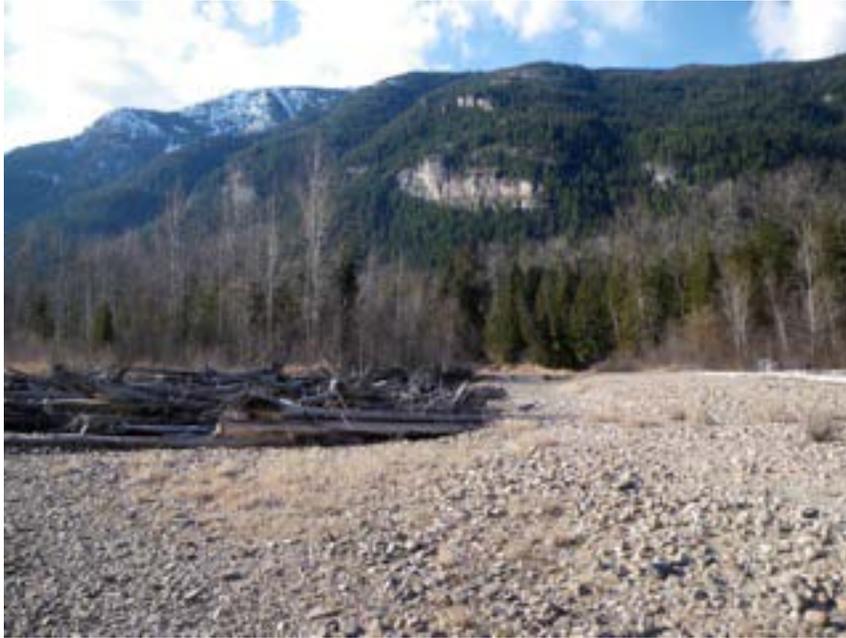
Figure 10. Ehlers side channel (2-8) looking downstream from the mouth.

This was a fairly significant channel at one time and may have once been the mainstem. The start of the channel has an old log jam that is now backed up by a gravel/cobble bar. There are 4 or 5 potential pools below the mouth. There is a cold ground water source in the channel. The lower half of the channel becomes quite slack and does not have trout restoration potential. There is good cover in place in the upper pool section as well as a smaller channel above the original opening that still functions adequately and is currently providing trout habitat.

This channel has good access through a developed property. The current landowners would be willing to participate in a restoration project at the channel mouth. Machine or hand tools could be employed to open this channel.

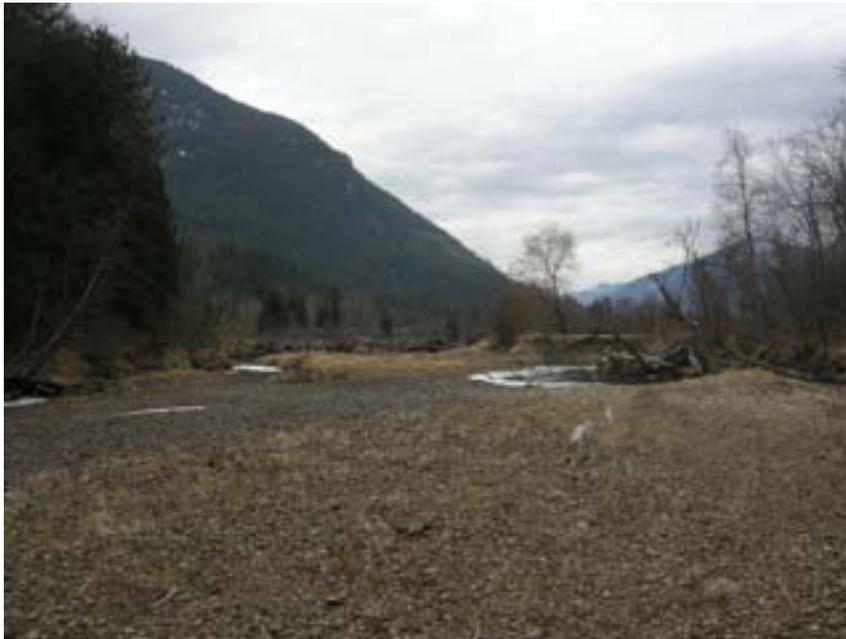
Figure 11. Mail Box side channel (4-6) looking up stream towards the mouth.

This is a short but relatively wide old channel with 2 openings. The upper opening is the most restricted with both logs and a gravel bar reducing stream flow to the channel. The lower opening has a log jam at its mouth but is still functioning adequately. There are 5 potential pools in this channel. The gradient of the lower half does lessen but in high water, there were numerous adult trout holding in this section. The near shoreline is substantially rip-wrapped as part of the old rail bed. The far shore island is crown land.

A machine would be required to open this channel along with extensive cutting into the logjam. Access would be from along the rails to trails.
