Columbia Lake Foreshore Integrated Management Planning – 2021

Wood Project# VE52823-2021B

Living Lakes Canada

31 March 2022

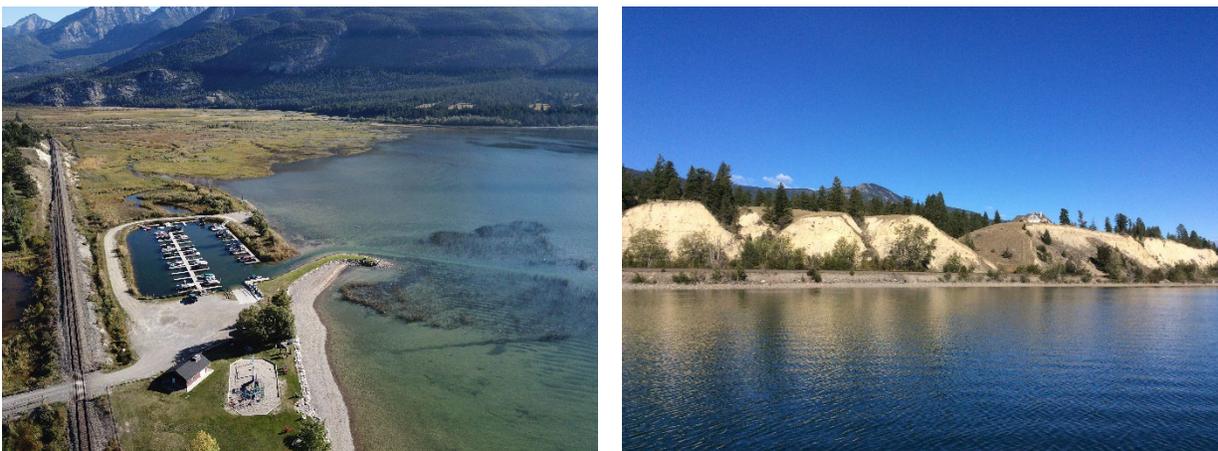
Figure 9: Example of shoreline modifications observed on Columbia Lake including docks within a marina, retaining wall, groyne and substrate modification in Segment 5 (left) and the railway line along the west side of the lake in Segment 7 (right).

The most prevalent lineal modification was erosion protection, which occurred along 16,398 m (41%) of the shoreline, followed by railway (15,172 m; 38%), substrate modification (2,009 m; 5%), retaining walls (1,082 m; 3%) and roadway (375 m; 1%; Figure 10). Erosion protection included retaining walls, groynes, and rip rap material along railways and roadways. A railway line is present along the entire west shoreline of the lake (Figure 9). Retaining walls were mainly associated with homes in Segment 1 and along an urban park in Segment 5. Substrate modification was mainly caused by beach grooming, imported sand and infilling along retaining walls. Roadways were associated with property and park access at the southeast end of the lake in Segment 1 (Appendix A).

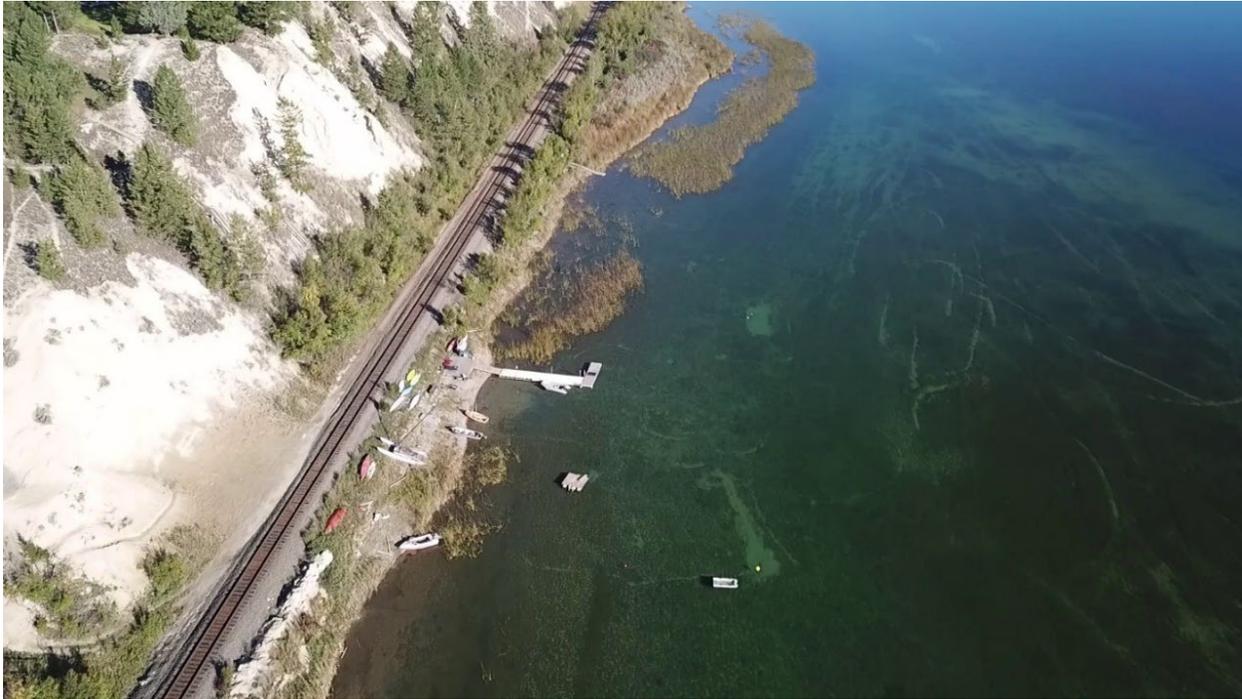
Figure 11: Erosion and aquatic vegetation disturbance caused by mooring buoy anchor scour and boat propeller drag observed along the west shoreline of Columbia Lake in Segment 6.

Disturbance of aquatic vegetation and littoral substrates was observed. Satellite and drone imagery suggested emergent aquatic vegetation had been removed to improve shoreline access at various locations. Aquatic vegetation was disturbed in lines caused by boat propeller drag through marl substrate in shallow littoral areas (Figure 11). Mooring buoy anchor/chain drag and scour disturbed benthic sediments and impacted the growth of submergent aquatic vegetation (Figure 11).

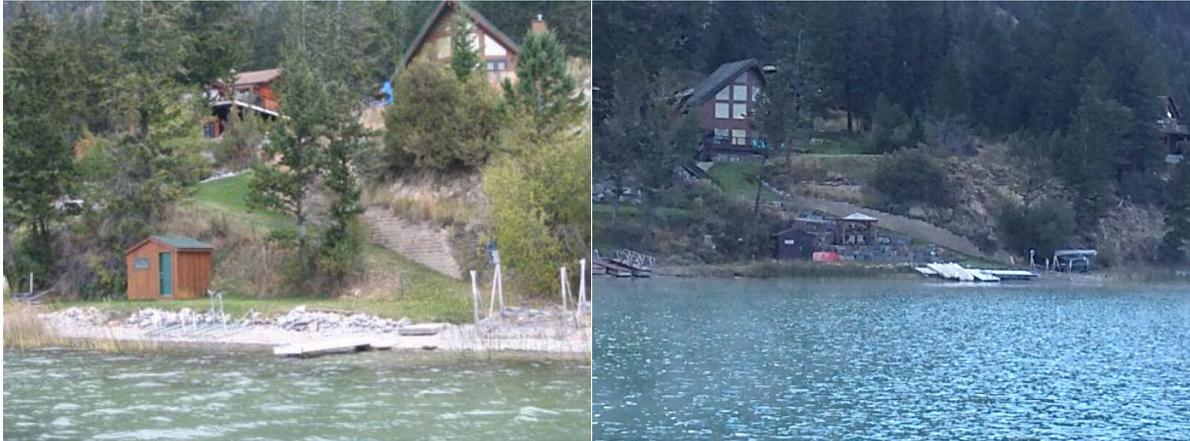
Figure 15: Photo of the southeast shoreline of Columbia Lake (Segment 1) in 2009 (left) and new retaining walls near the shoreline in 2021 (right).

This suggests the amount of disturbance in Segment 1 is increasing by approximately 6.8 m (0.4% of the segment) per year.

Shoreline disturbance increased in one segment in the southeast corner of the lake near Canal Flats (Segment 1). New single family residential developments had been constructed or were in construction during the 2021 re-FIM survey and new docks and retaining walls were also documented. Undeveloped shoreline properties in Segment 1 are mainly zoned for residential use and it is likely more development will occur in the future. However, some residential lots have been developed in a way that limits shoreline impacts by maintaining riparian areas and minimizing the number of shoreline modifications. McPherson et al. (2010) showcased a property in Segment 1 as an example of how future planning could be undertaken (Figure 21). This same property in 2021 was observed to retain these features (i.e., intact emergent and riparian vegetation and a lack of shoreline modifications) (Figure 21). However, in 2021 it was noted that modifications have increased at other properties in Segment 1 (e.g., Figure 15).

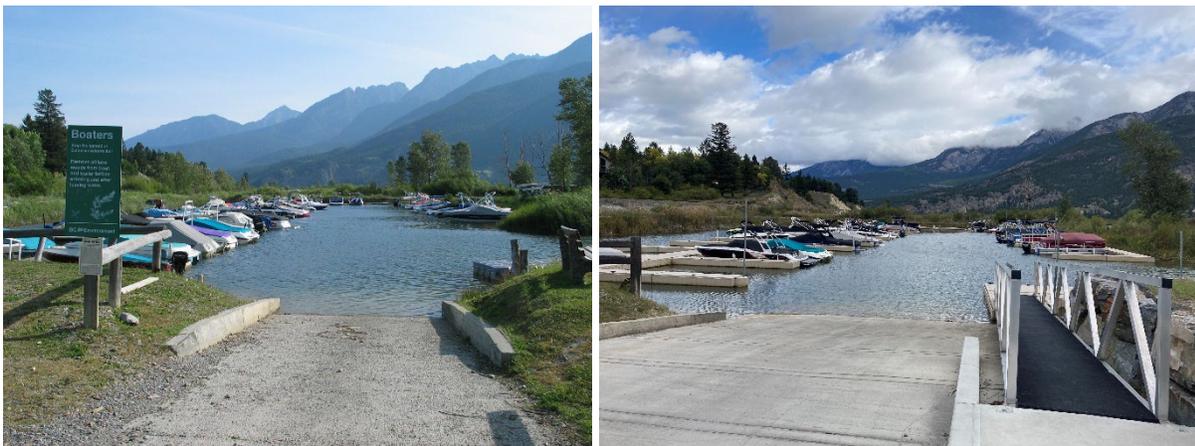
Figure 16: Photo of the Columere Park marina (Segment 5) in 2009 (left) and in 2021 (right).

Disturbance may have also increased in areas that were already disturbed in 2009 (e.g., Segments 5, 6 and 7) that did not change the percentage of the segment disturbed. Additional modifications were observed in some segments where the overall level of disturbance did not change (see Section 3.1.10.5). For example, upgrades to the Columere Park private marina (Segment 5) since the 2009 FIM survey were observed including expansion and resurfacing of the existing boat launch, new dock, new retaining wall adjacent to the boat launch, new boat slips and vegetation clearing (Figure 16). The shoreline of Segment 5 had already been classified as 100% disturbed in 2009, therefore, the additional modification observed in 2021 did not result in a change to this classification.

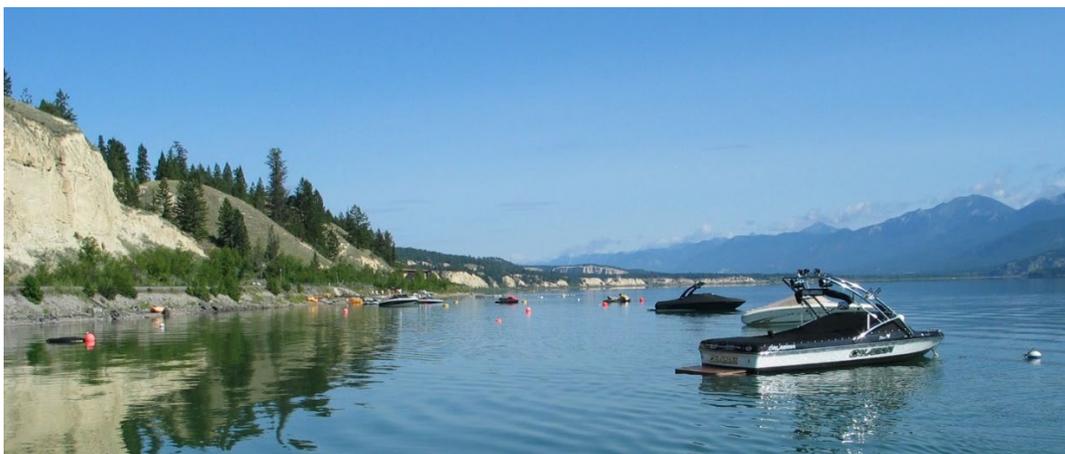
Figure 19: Photo of mooring buoys observed near the community of Columbia Ridge during the 2009 FIM survey.

Comparison of other modifications such as mooring buoys and substrate modification could not be made quantitatively because they had not been inventoried during the 2009 surveys. However, review of photo documentation taken in Segment 6 in 2009 suggests there were less mooring buoys in 2021 compared with 2009. Photographs depict at least 16 mooring buoys at a shoreline access point below Columbia Ridge in 2009 (Figure 19) while the 2021 survey inventoried only six in approximately the same location (see points identified on maps in Appendix A). Local residents suggest there are approximately 31 mooring buoys at Columbia Ridge in peak summer (CLSS, pers. comm., 2022). Similar observations were made in other areas of the lake including Timber Springs where five mooring buoys were documented in September 2021 whereas up to nine can be present during the summer season (CLSS, pers. comm., 2022). Based on these observations, it is likely some mooring buoys had been removed for the season when the 2021 re-FIM survey was conducted.

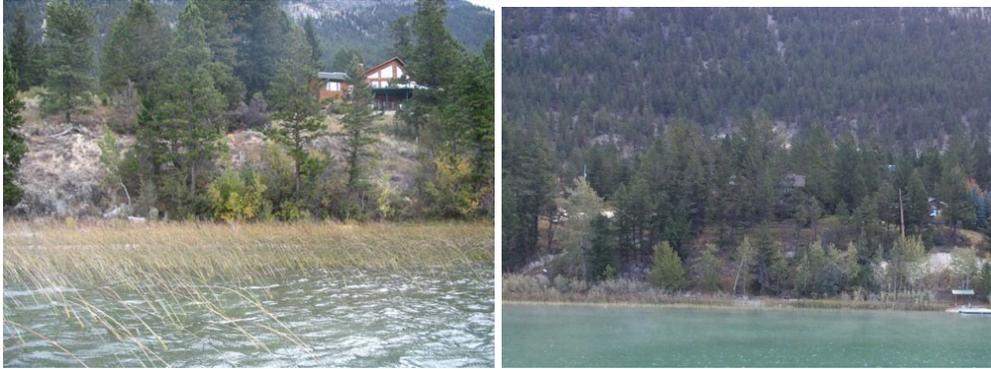
Figure 21: Photo of a residence in Segment 1 in 2009 (left) presented as an example of development that minimized foreshore disturbance by McPherson et al. (2010). An updated photo of the residence was taken in 2021 with the roofline now mostly hidden by coniferous trees at the middle of the photo (right).

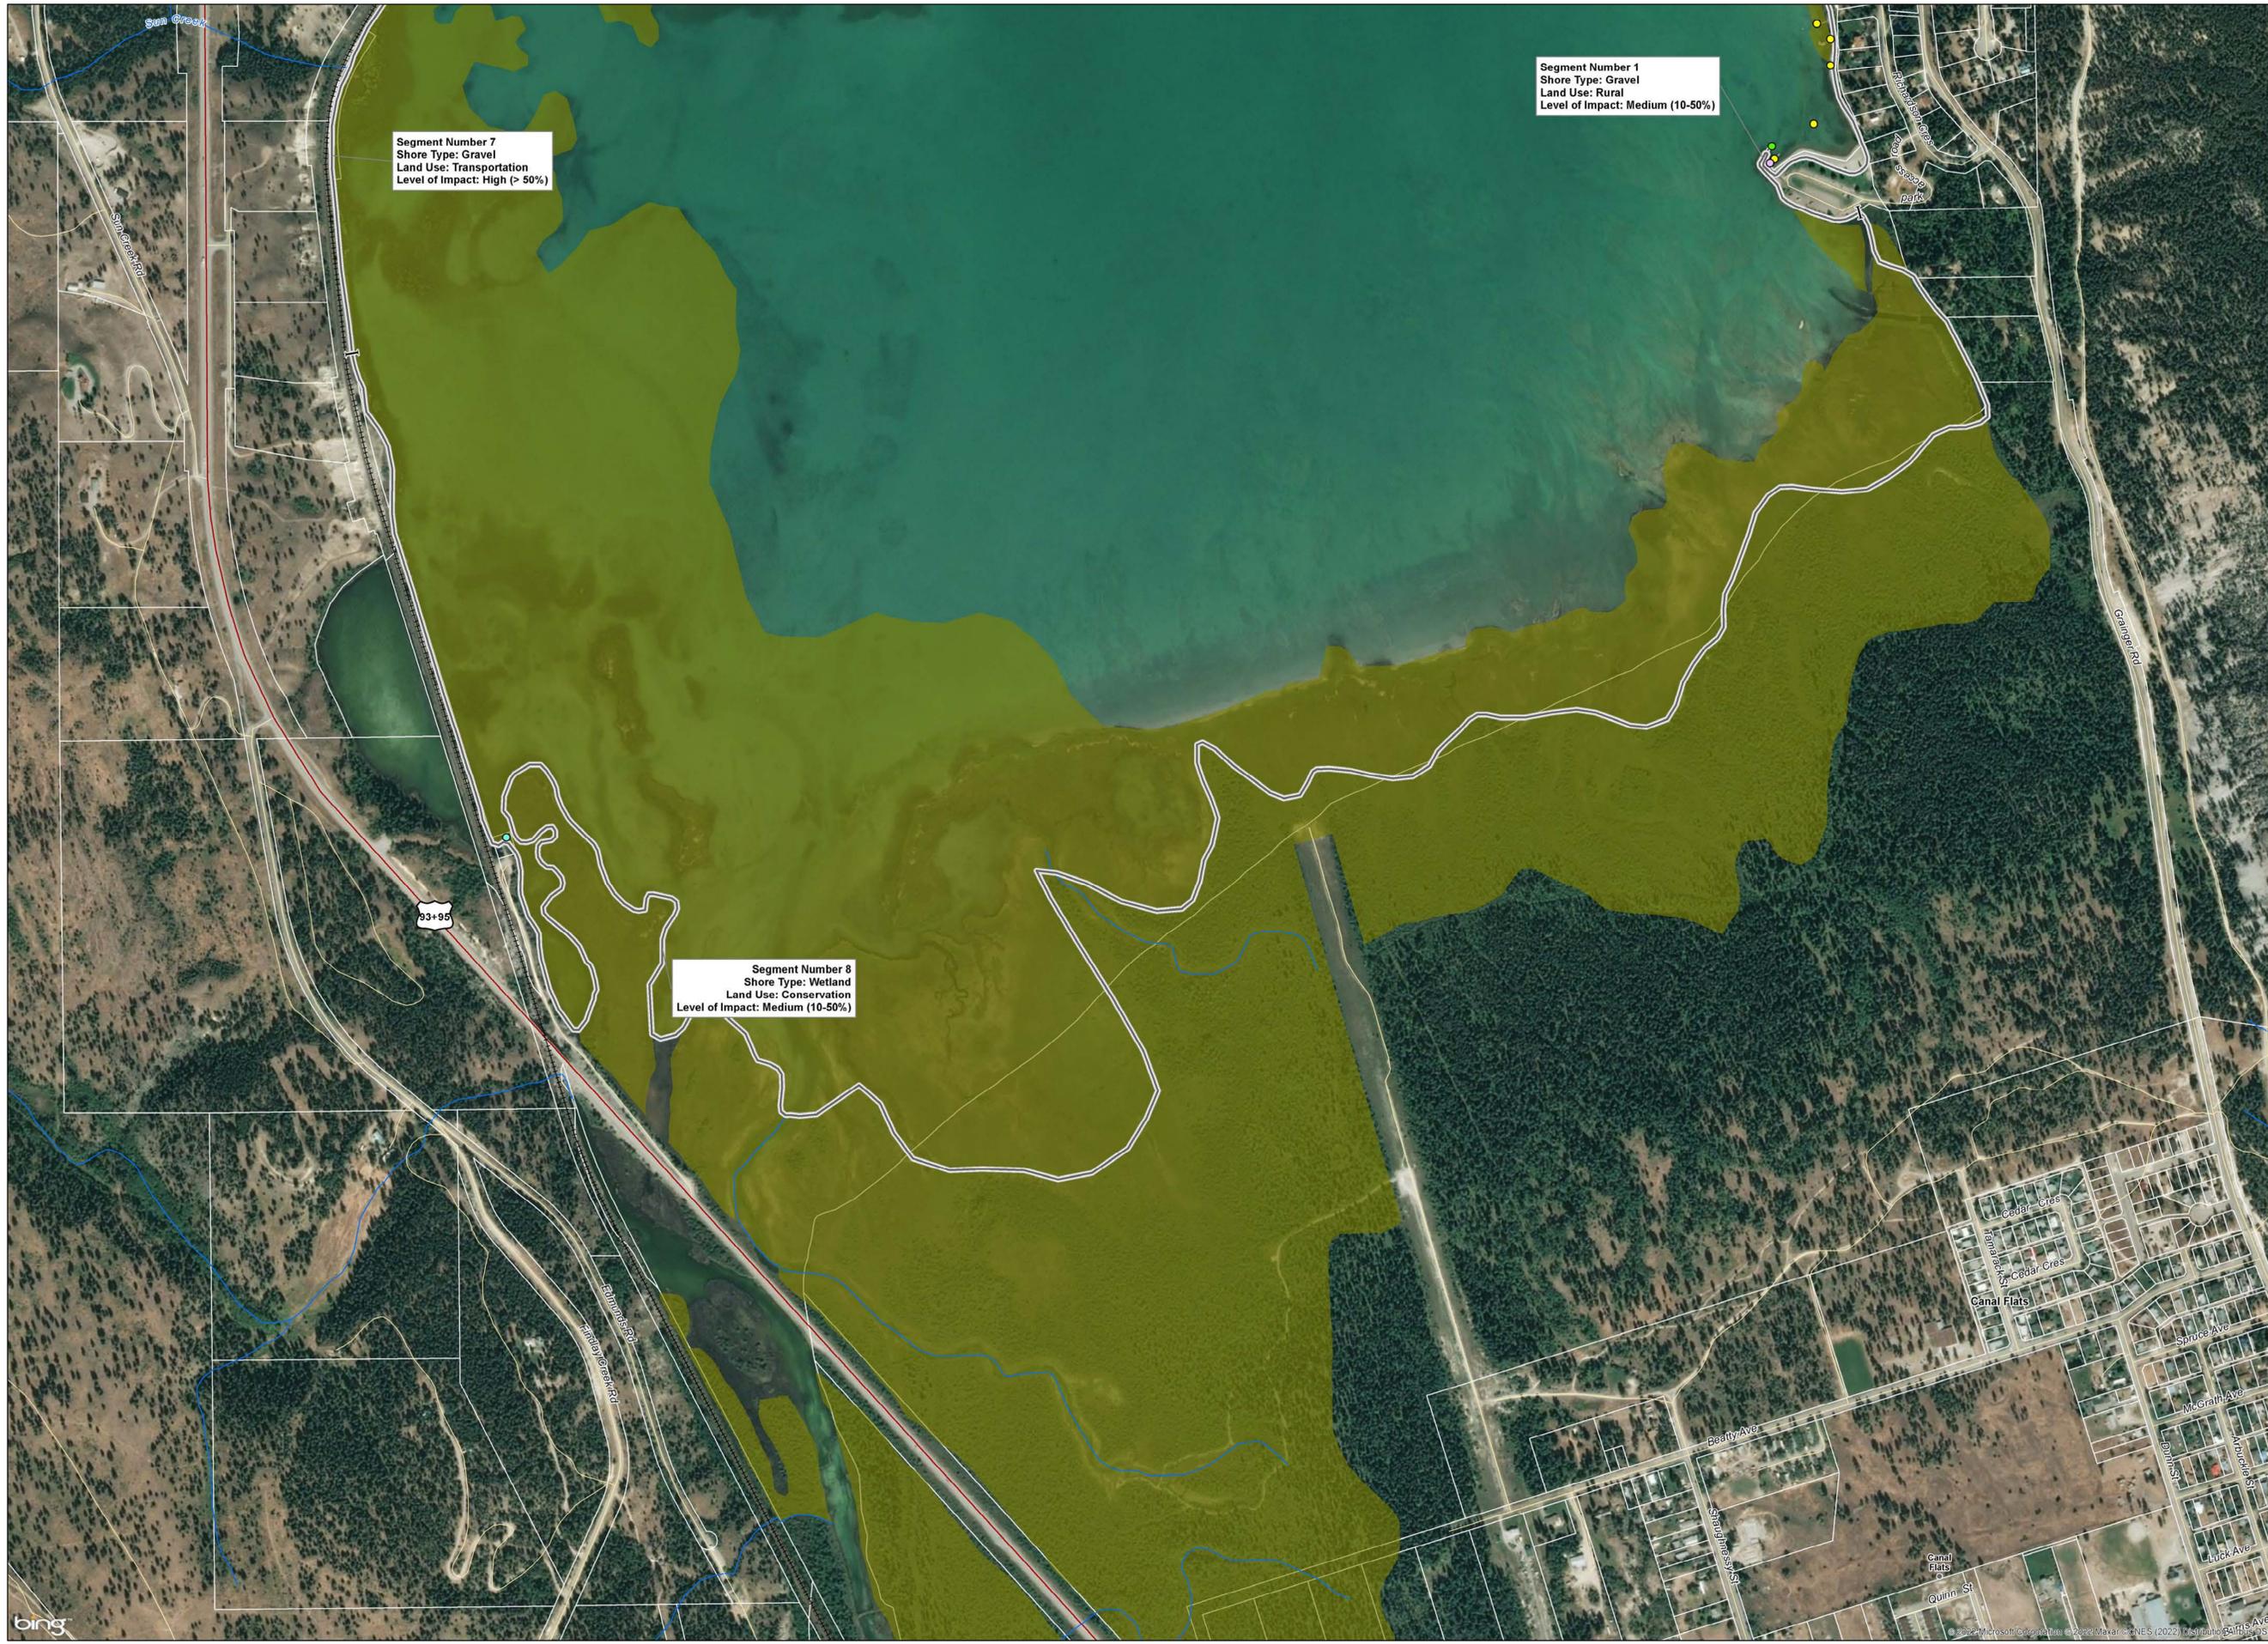
Segment Number 7
 Shore Type: Gravel
 Land Use: Transportation
 Level of Impact: High (> 50%)

Segment Number 1
 Shore Type: Gravel
 Land Use: Rural
 Level of Impact: Medium (10-50%)

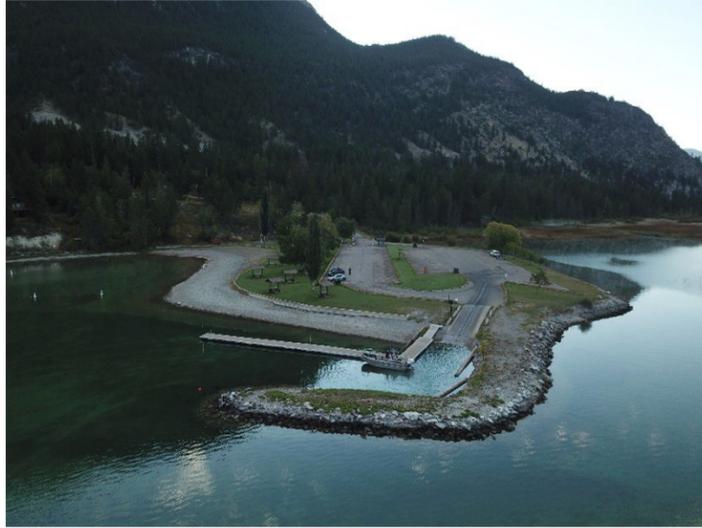
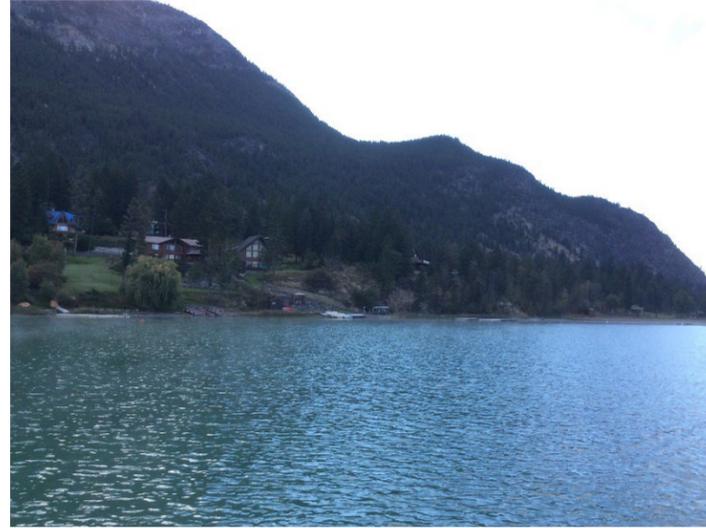
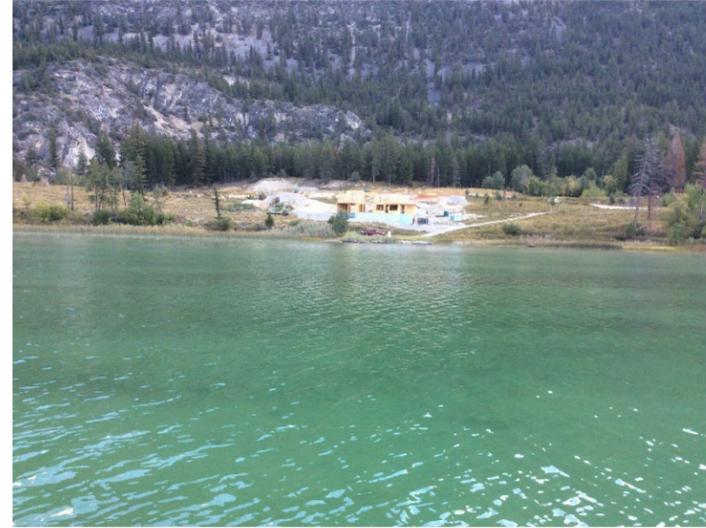
Columbia Lake Segment 1

Segment Length (m)	Shore Type	Shore Type Modification	Slope	Land Use	Level of Impact	Livestock Access	Disturbed	Natural
1877	Gravel	Roadway	Steep (20-60%)	Rural	Medium (10-50%)	No	48%	52%

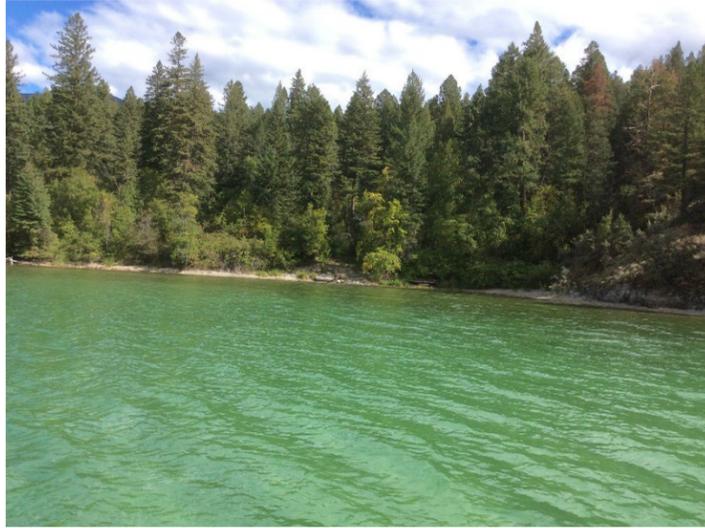
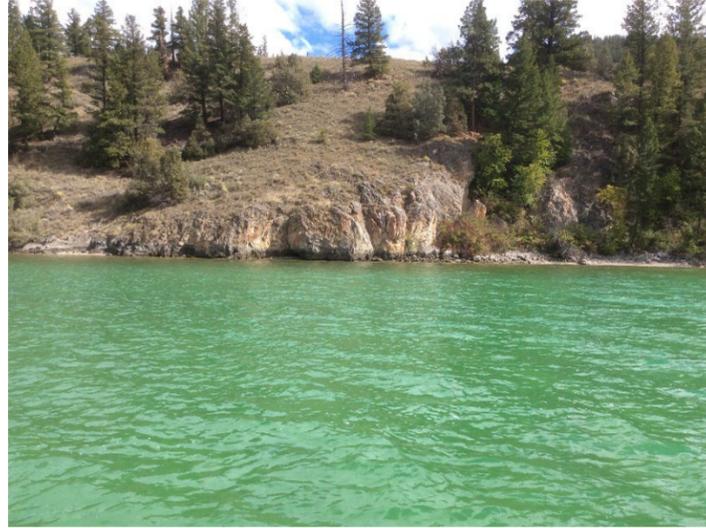
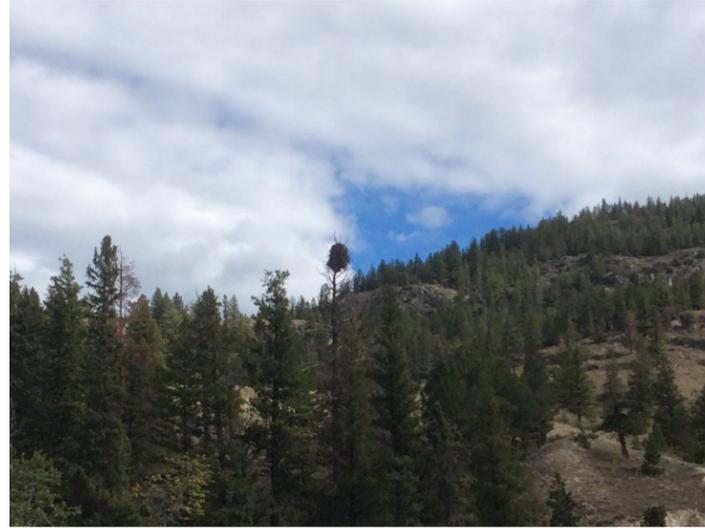
Columbia Lake Segment 2

Segment Length (m)	Shore Type	Shore Type Modification	Slope	Land Use	Level of Impact	Livestock Access	Disturbed	Natural
2329	Gravel	None	Steep (20-60%)	Conservation	Low (< 10%)	No	0%	100%

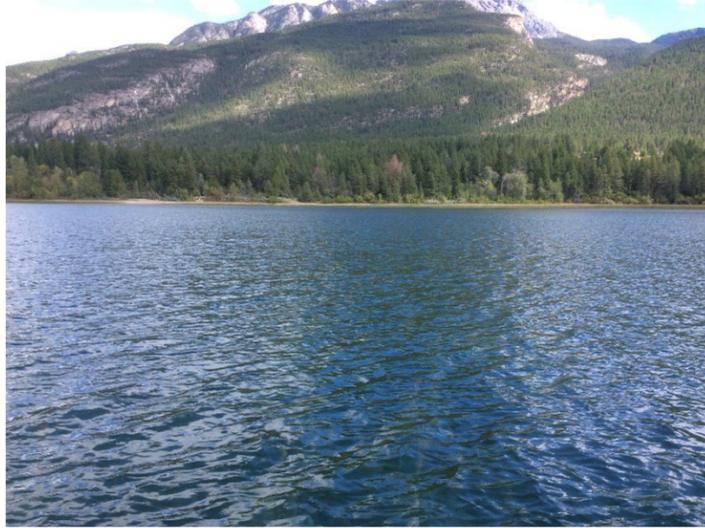
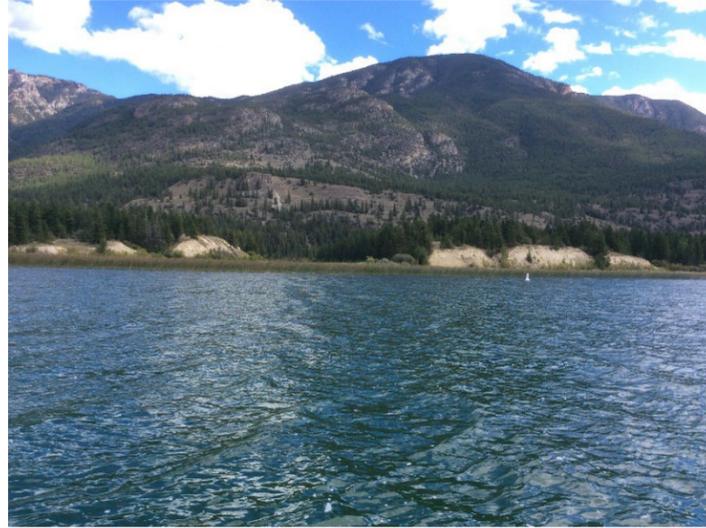
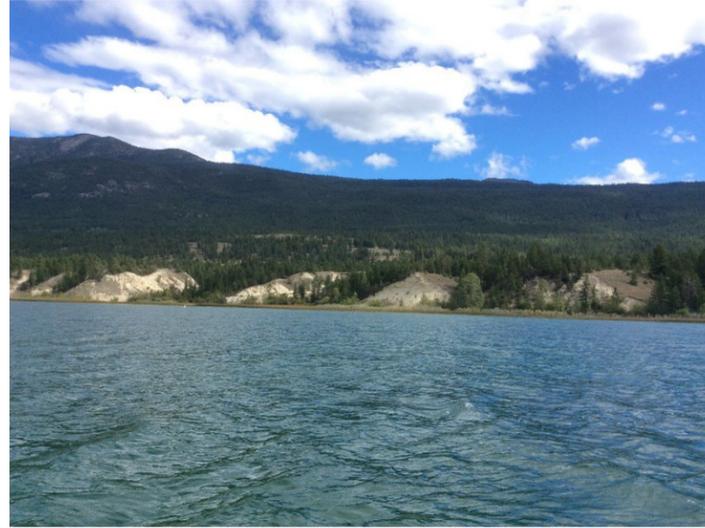
Columbia Lake Segment 3

Segment Length (m)	Shore Type	Shore Type Modification	Slope	Land Use	Level of Impact	Livestock Access	Disturbed	Natural
12952	Cliff / Bluff	None	Steep (20-60%)	Conservation	Low (< 10%)	No	0%	100%

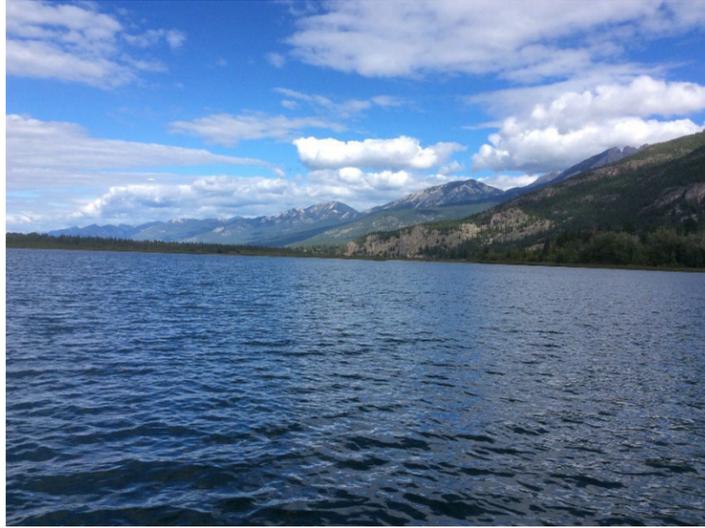
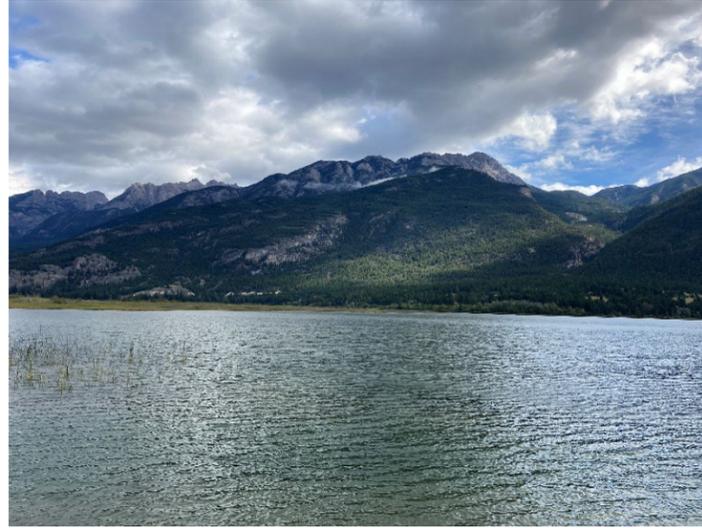
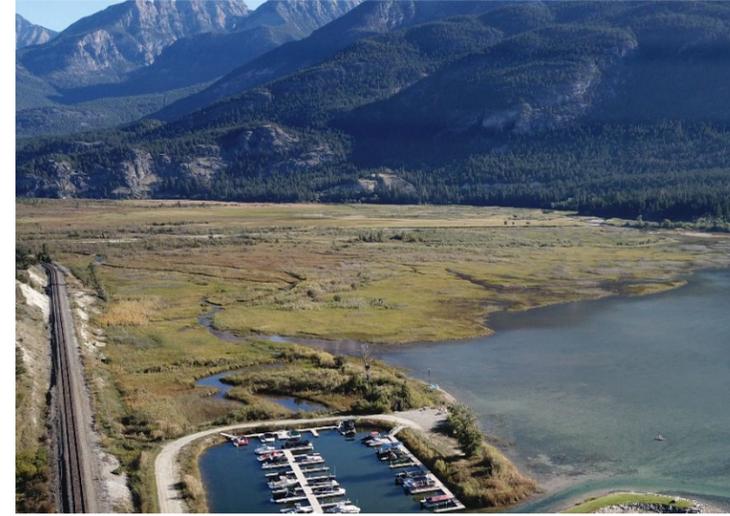
Columbia Lake Segment 4

Segment Length (m)	Shore Type	Shore Type Modification	Slope	Land Use	Level of Impact	Livestock Access	Disturbed	Natural
1181	Wetland	None	Low (< 5%)	Conservation	Low (< 10%)	No	0%	100%

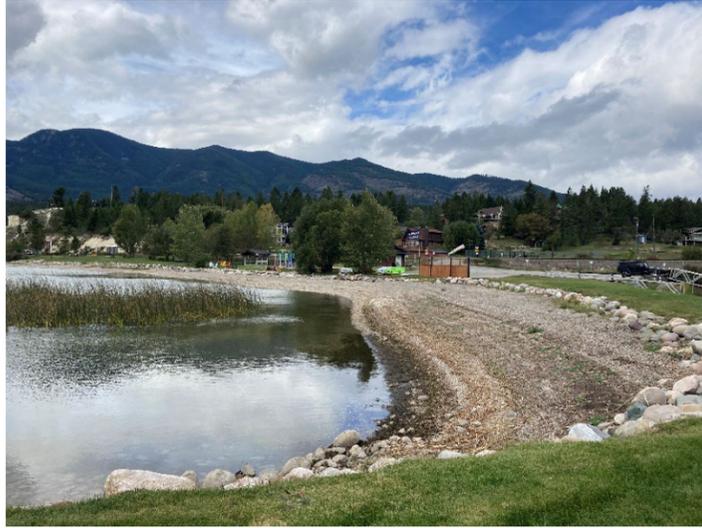
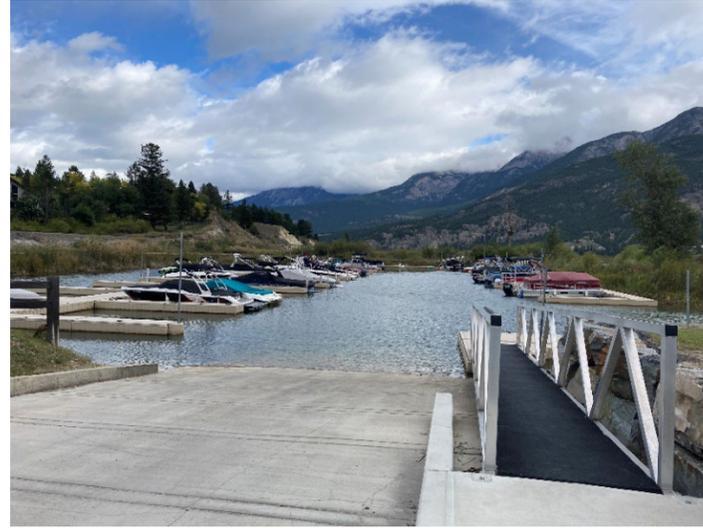
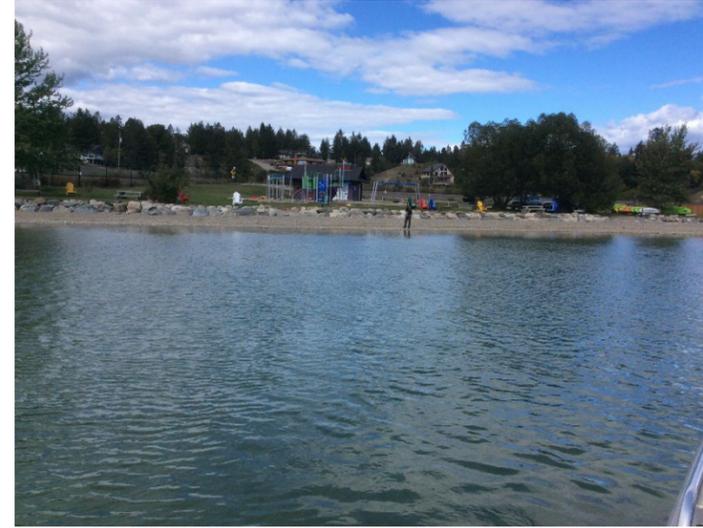
Columbia Lake Segment 5

Segment Length (m)	Shore Type	Shore Type Modification	Slope	Land Use	Level of Impact	Livestock Access	Disturbed	Natural
764	Gravel	Large Marina (>20 Slips)	Low (< 5%)	Urban Park	High (> 50%)	No	100%	0%

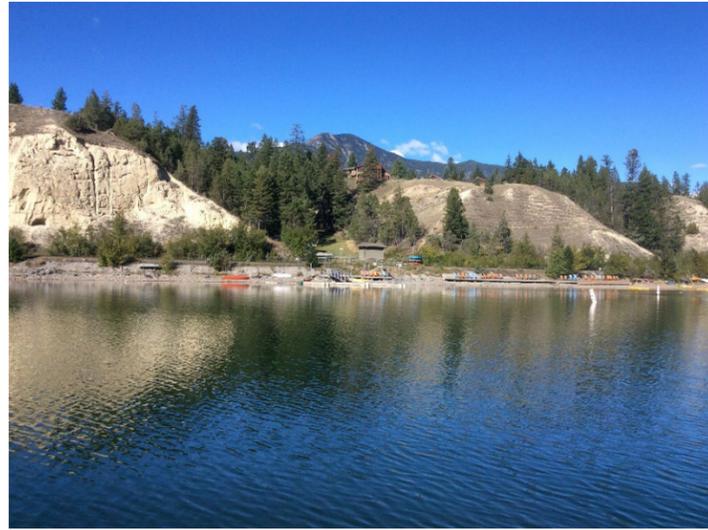
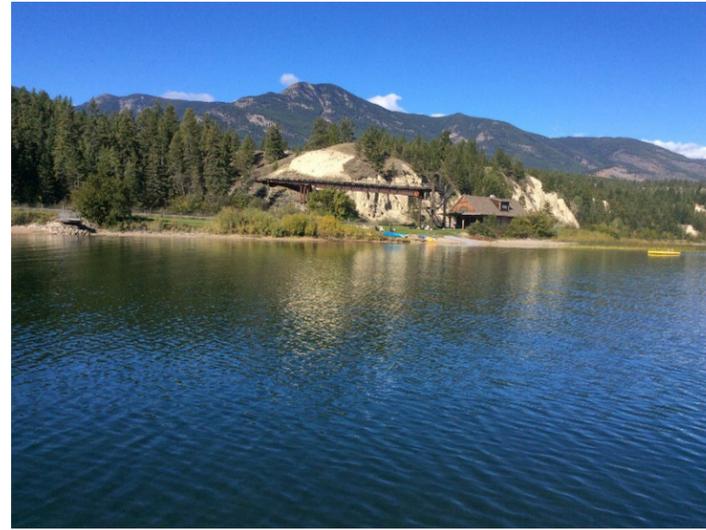
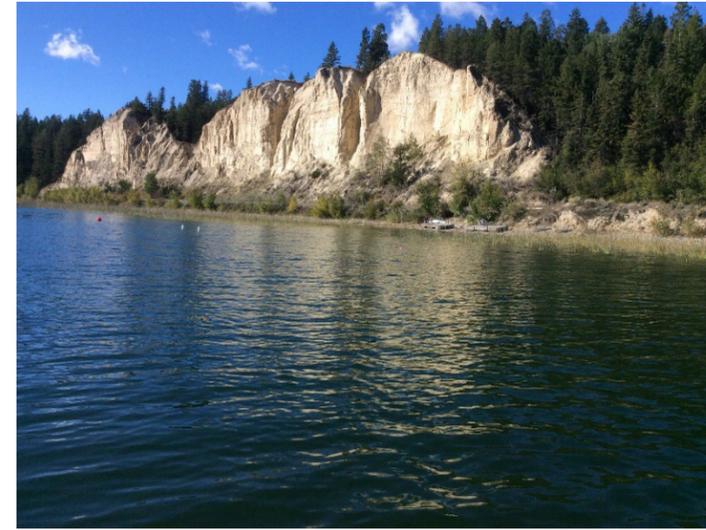
Columbia Lake Segment 6

Segment Length (m)	Shore Type	Shore Type Modification	Slope	Land Use	Level of Impact	Livestock Access	Disturbed	Natural
7173	Gravel	Railway	Steep (20-60%)	Transportation	High (> 50%)	No	95%	5%

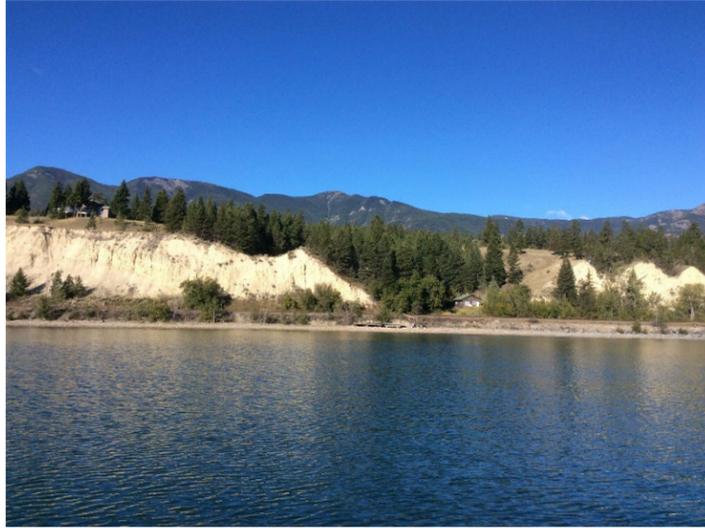
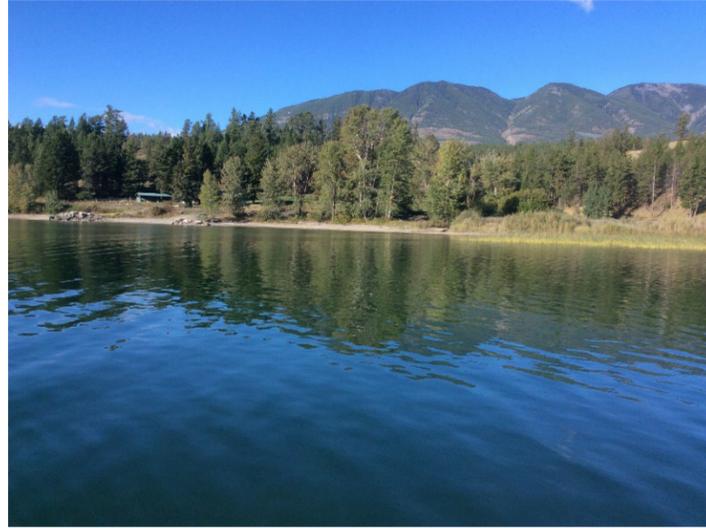
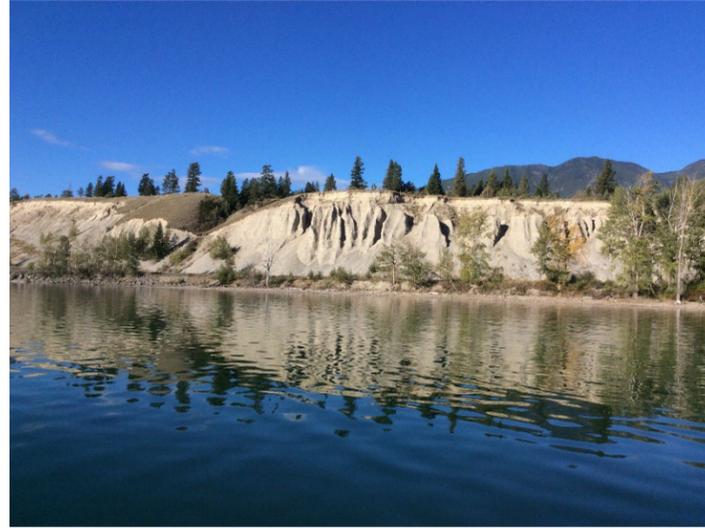
Columbia Lake Segment 7

Segment Length (m)	Shore Type	Shore Type Modification	Slope	Land Use	Level of Impact	Livestock Access	Disturbed	Natural
6706	Gravel	Railway	Steep (20-60%)	Transportation	High (> 50%)	No	100%	0%

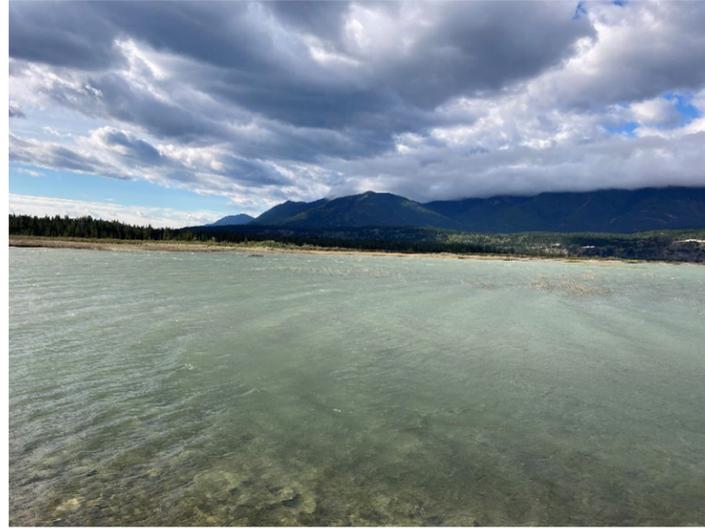
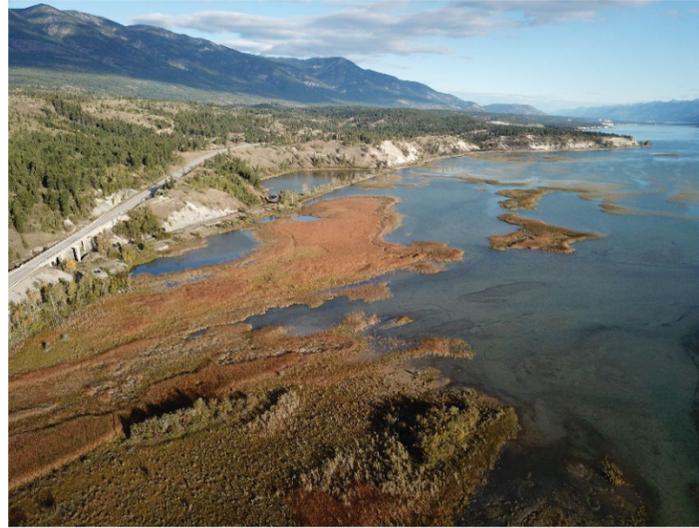
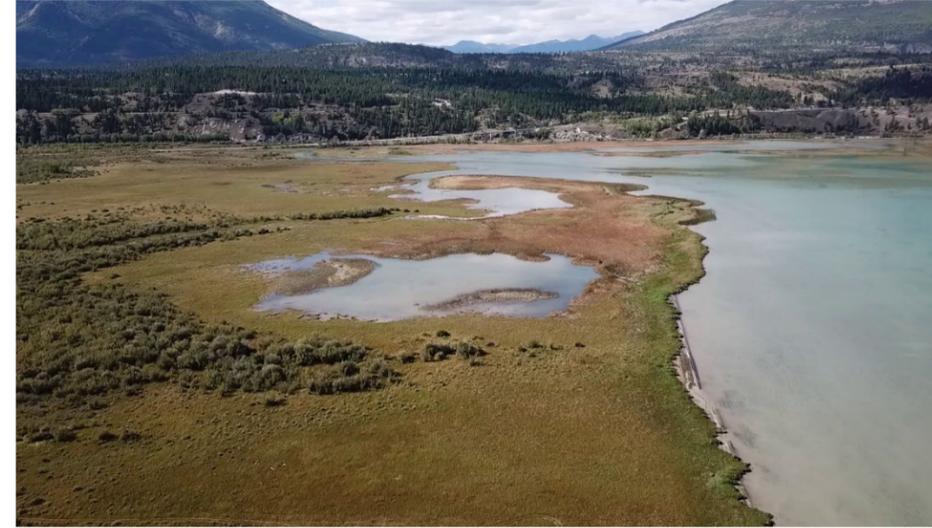
Columbia Lake Segment 8

Segment Length (m)	Shore Type	Shore Type Modification	Slope	Land Use	Level of Impact	Livestock Access	Disturbed	Natural
6581	Wetland	Railway	Low (< 5%)	Conservation	Medium (10-50%)	No	15%	85%

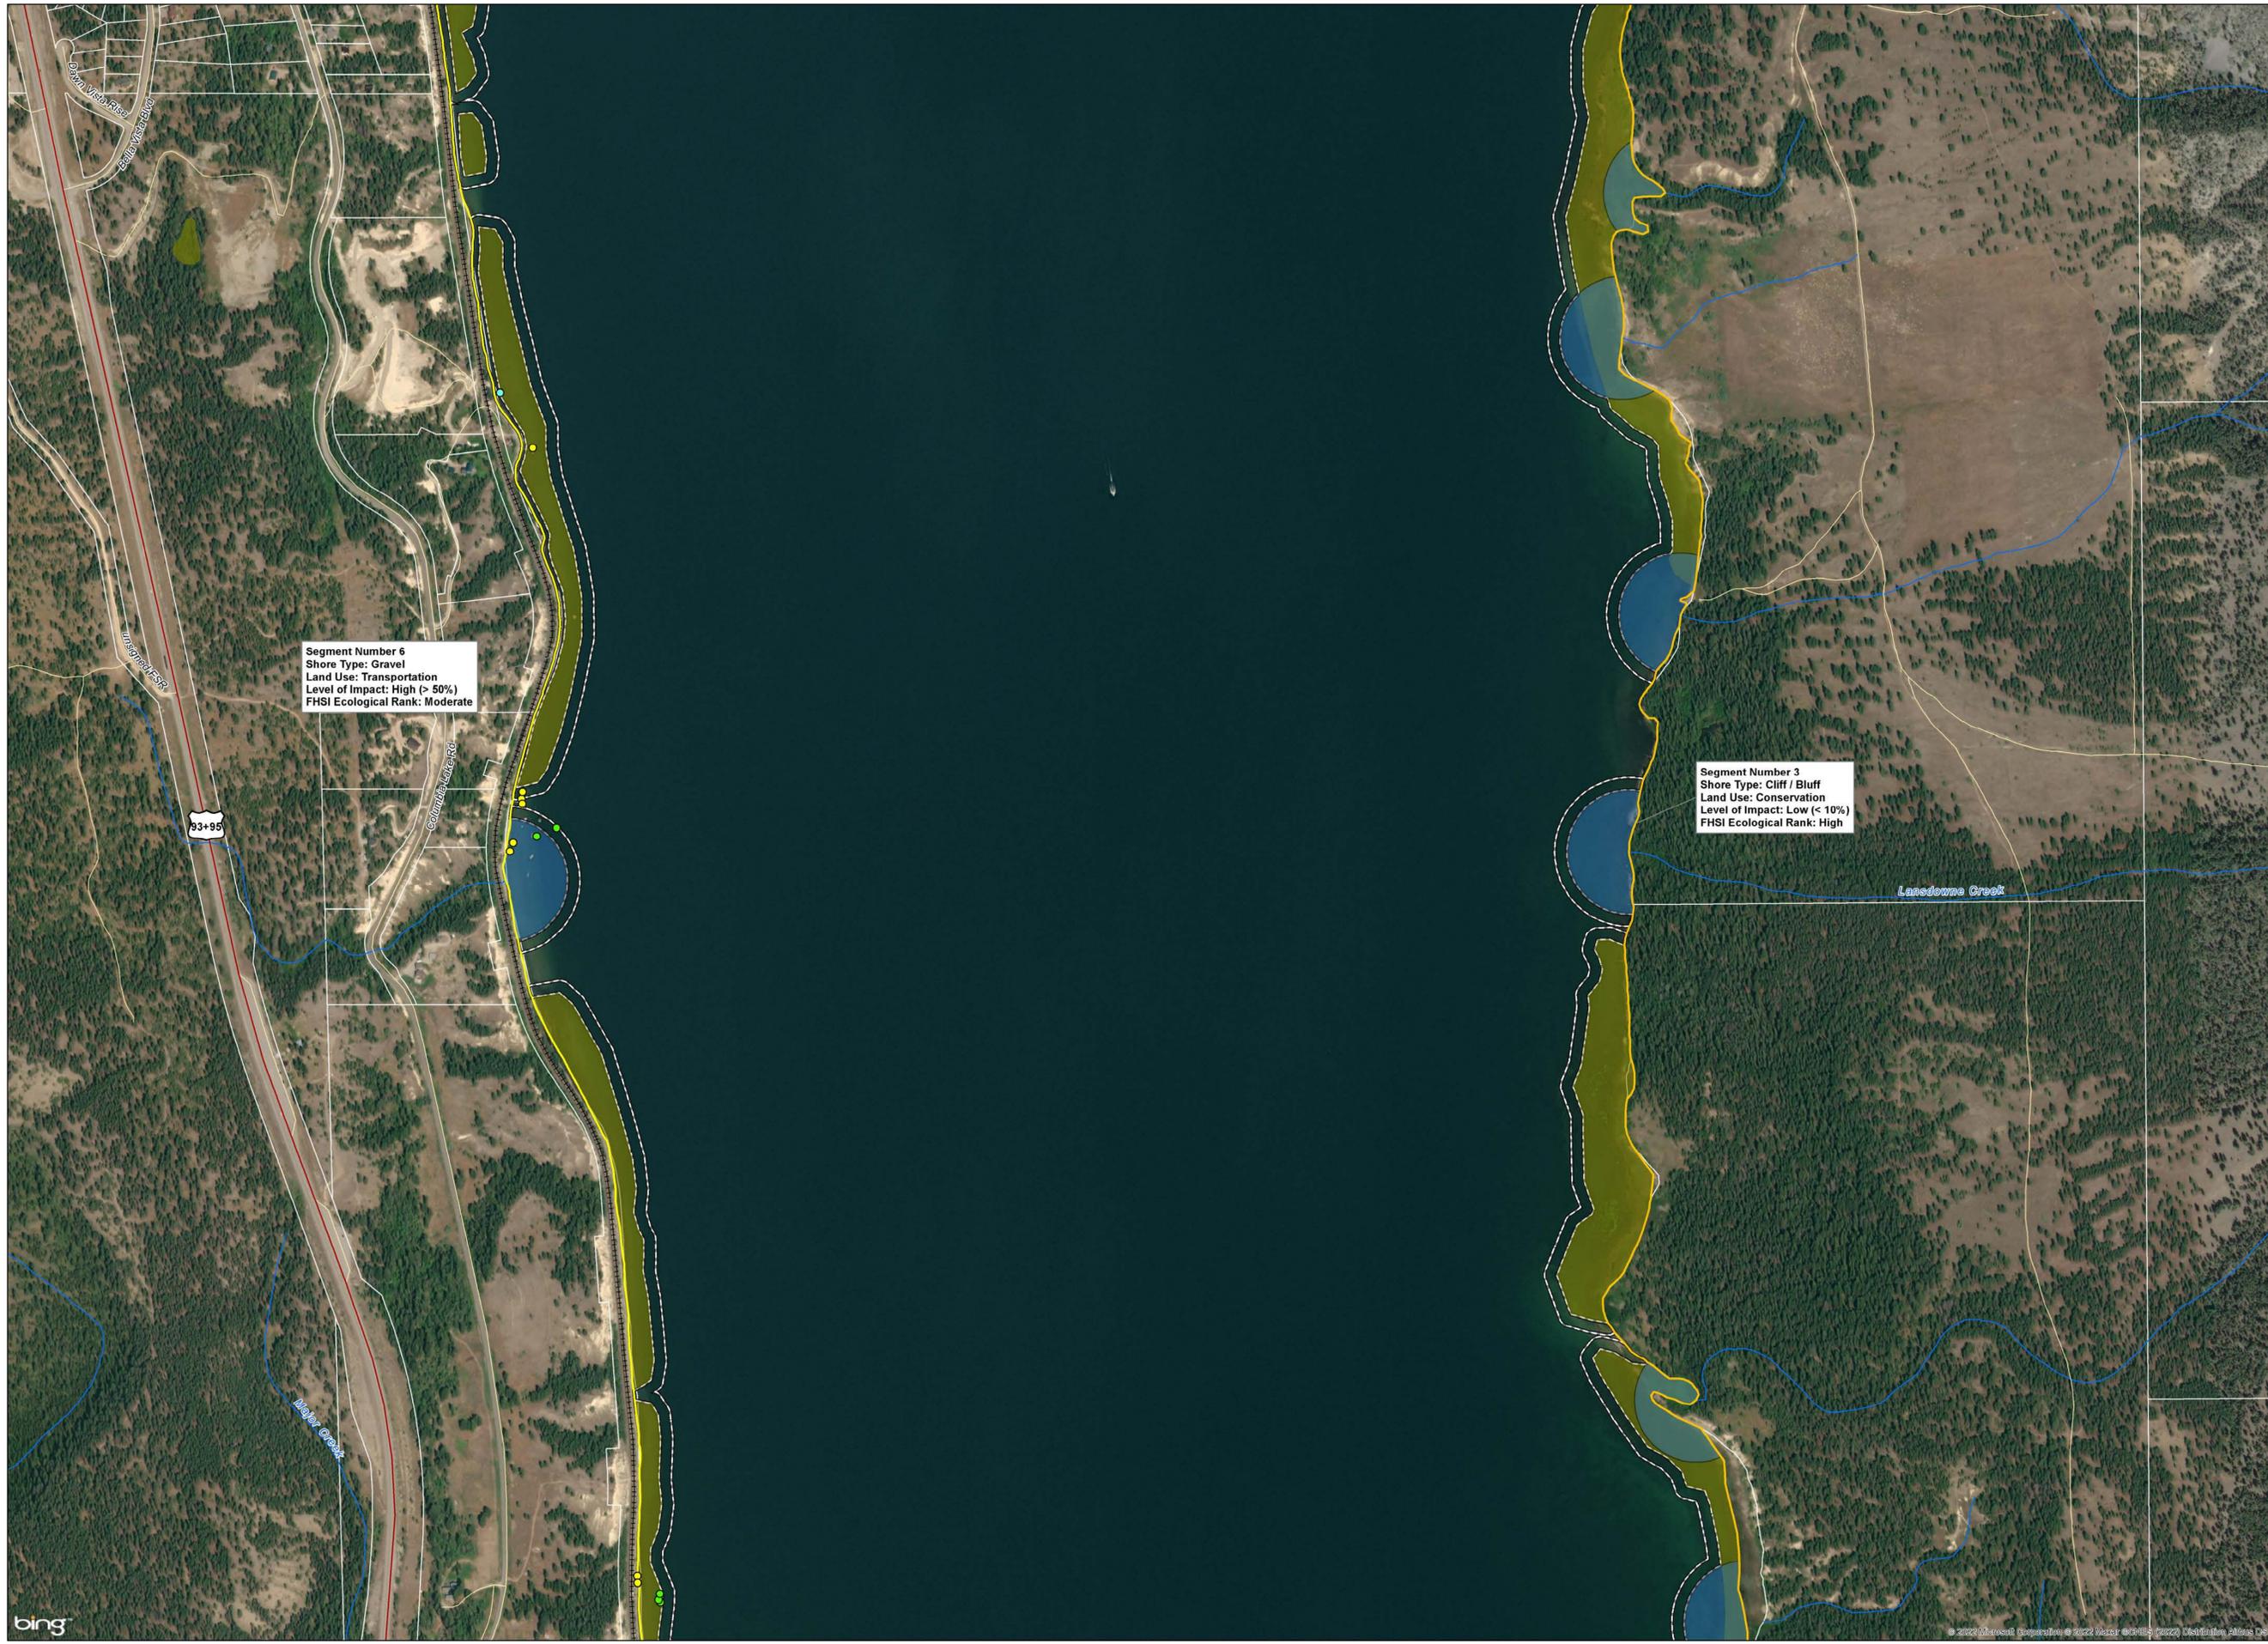
Segment Number 6
 Shore Type: Gravel
 Land Use: Transportation
 Level of Impact: High (> 50%)
 FHSI Ecological Rank: Moderate

Segment Number 3
 Shore Type: Cliff / Bluff
 Land Use: Conservation
 Level of Impact: Low (< 10%)
 FHSI Ecological Rank: High
