Columbia Lake Foreshore Integrated Management Planning – 2021

Wood Project# VE52823-2021B

Living Lakes Canada

31 March 2022

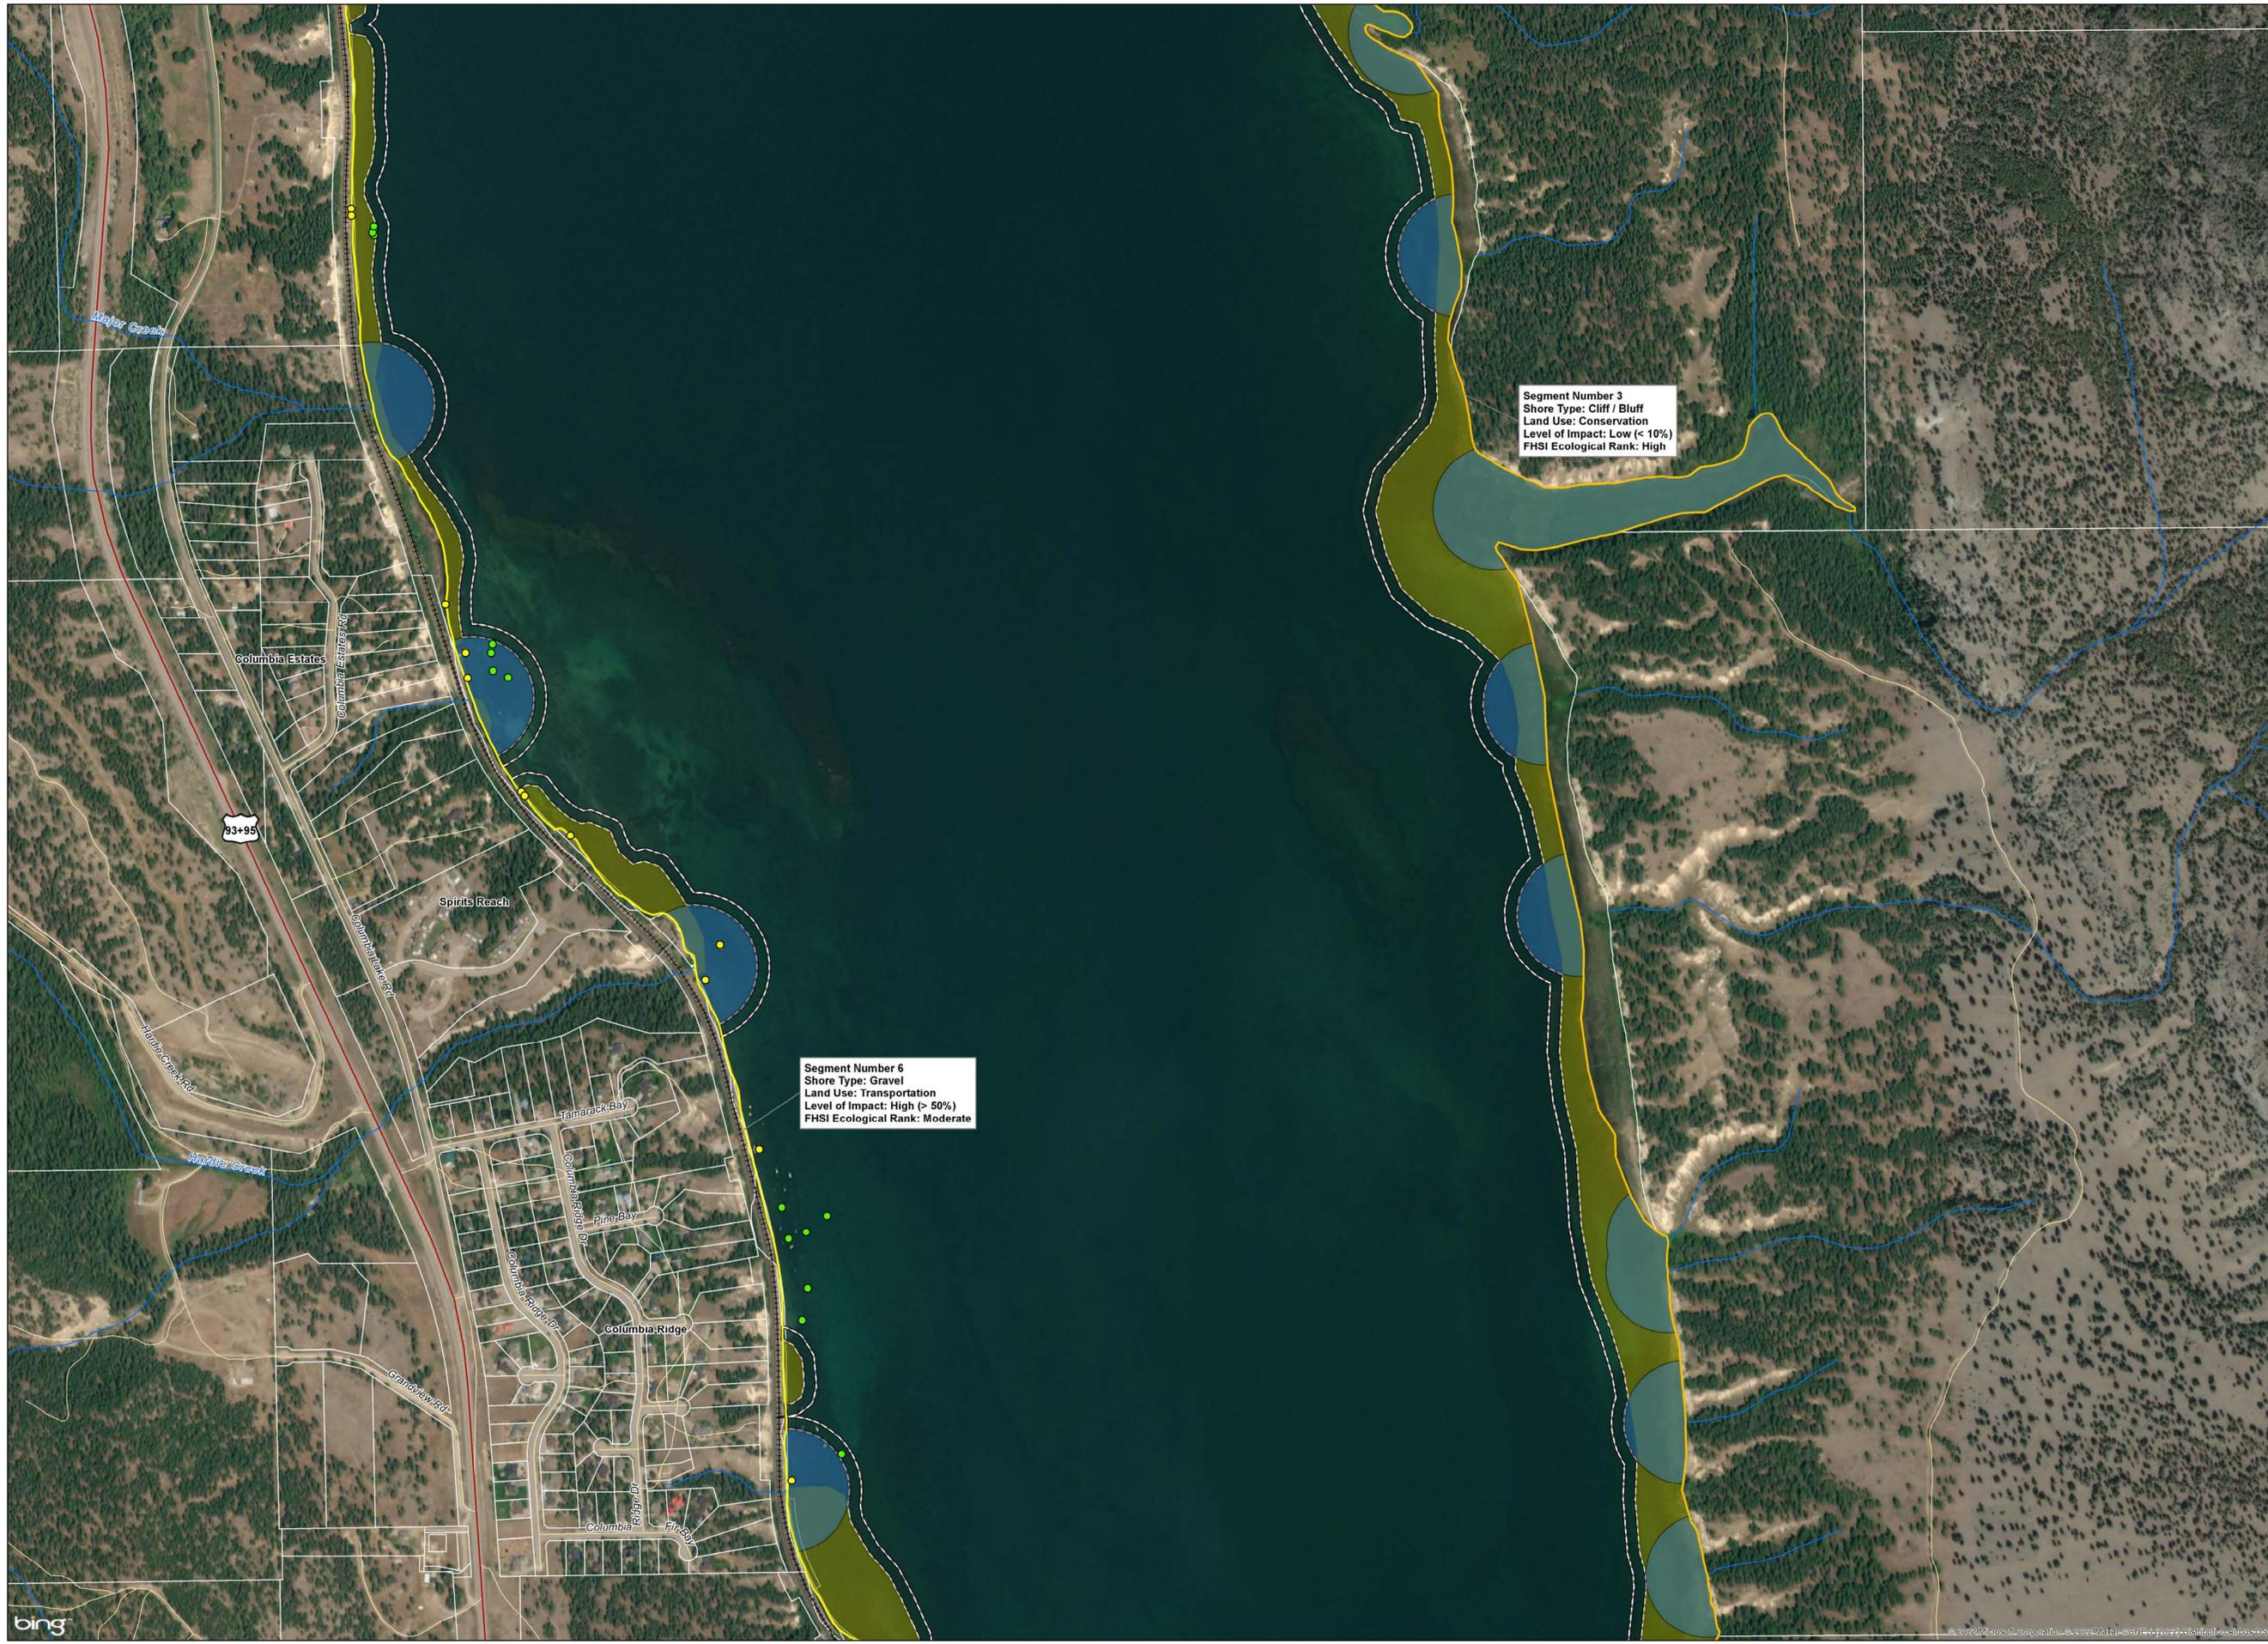
Segment Number 3
 Shore Type: Cliff / Bluff
 Land Use: Conservation
 Level of Impact: Low (< 10%)
 FHSI Ecological Rank: High

Segment Number 6
 Shore Type: Gravel
 Land Use: Transportation
 Level of Impact: High (> 50%)
 FHSI Ecological Rank: Moderate

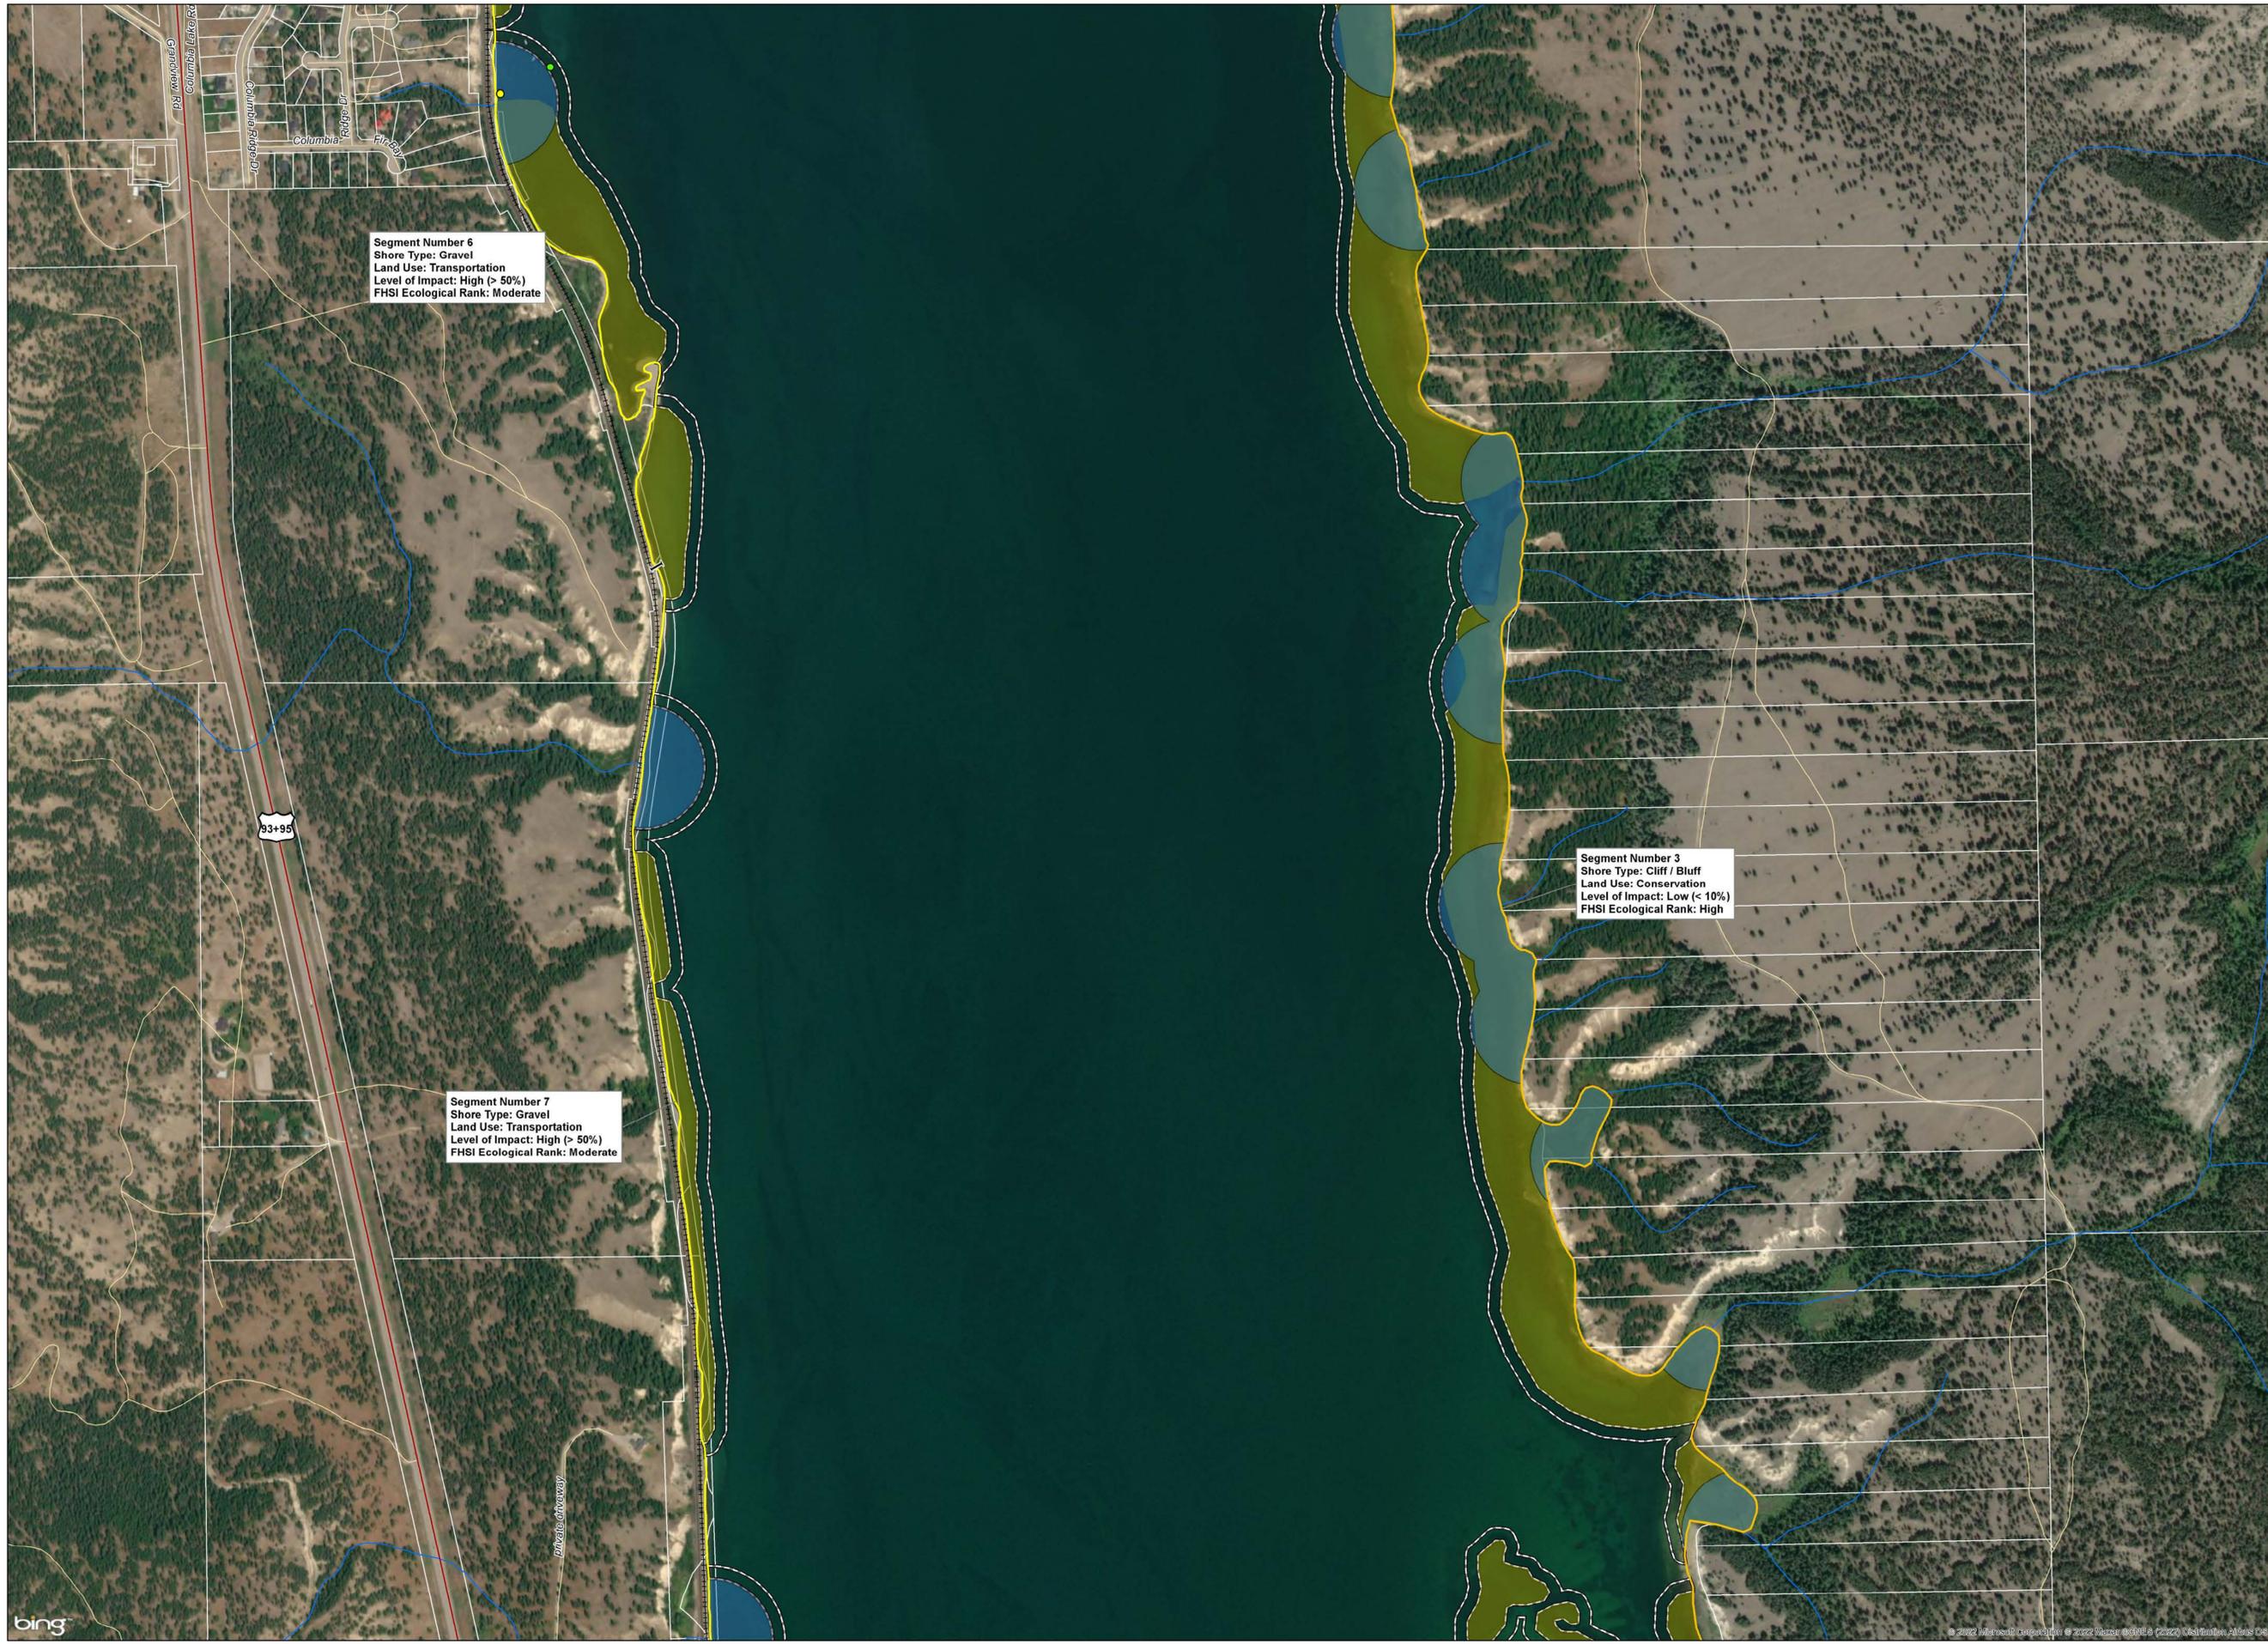
Segment Number 6
 Shore Type: Gravel
 Land Use: Transportation
 Level of Impact: High (> 50%)
 FHSI Ecological Rank: Moderate

Segment Number 3
 Shore Type: Cliff / Bluff
 Land Use: Conservation
 Level of Impact: Low (< 10%)
 FHSI Ecological Rank: High

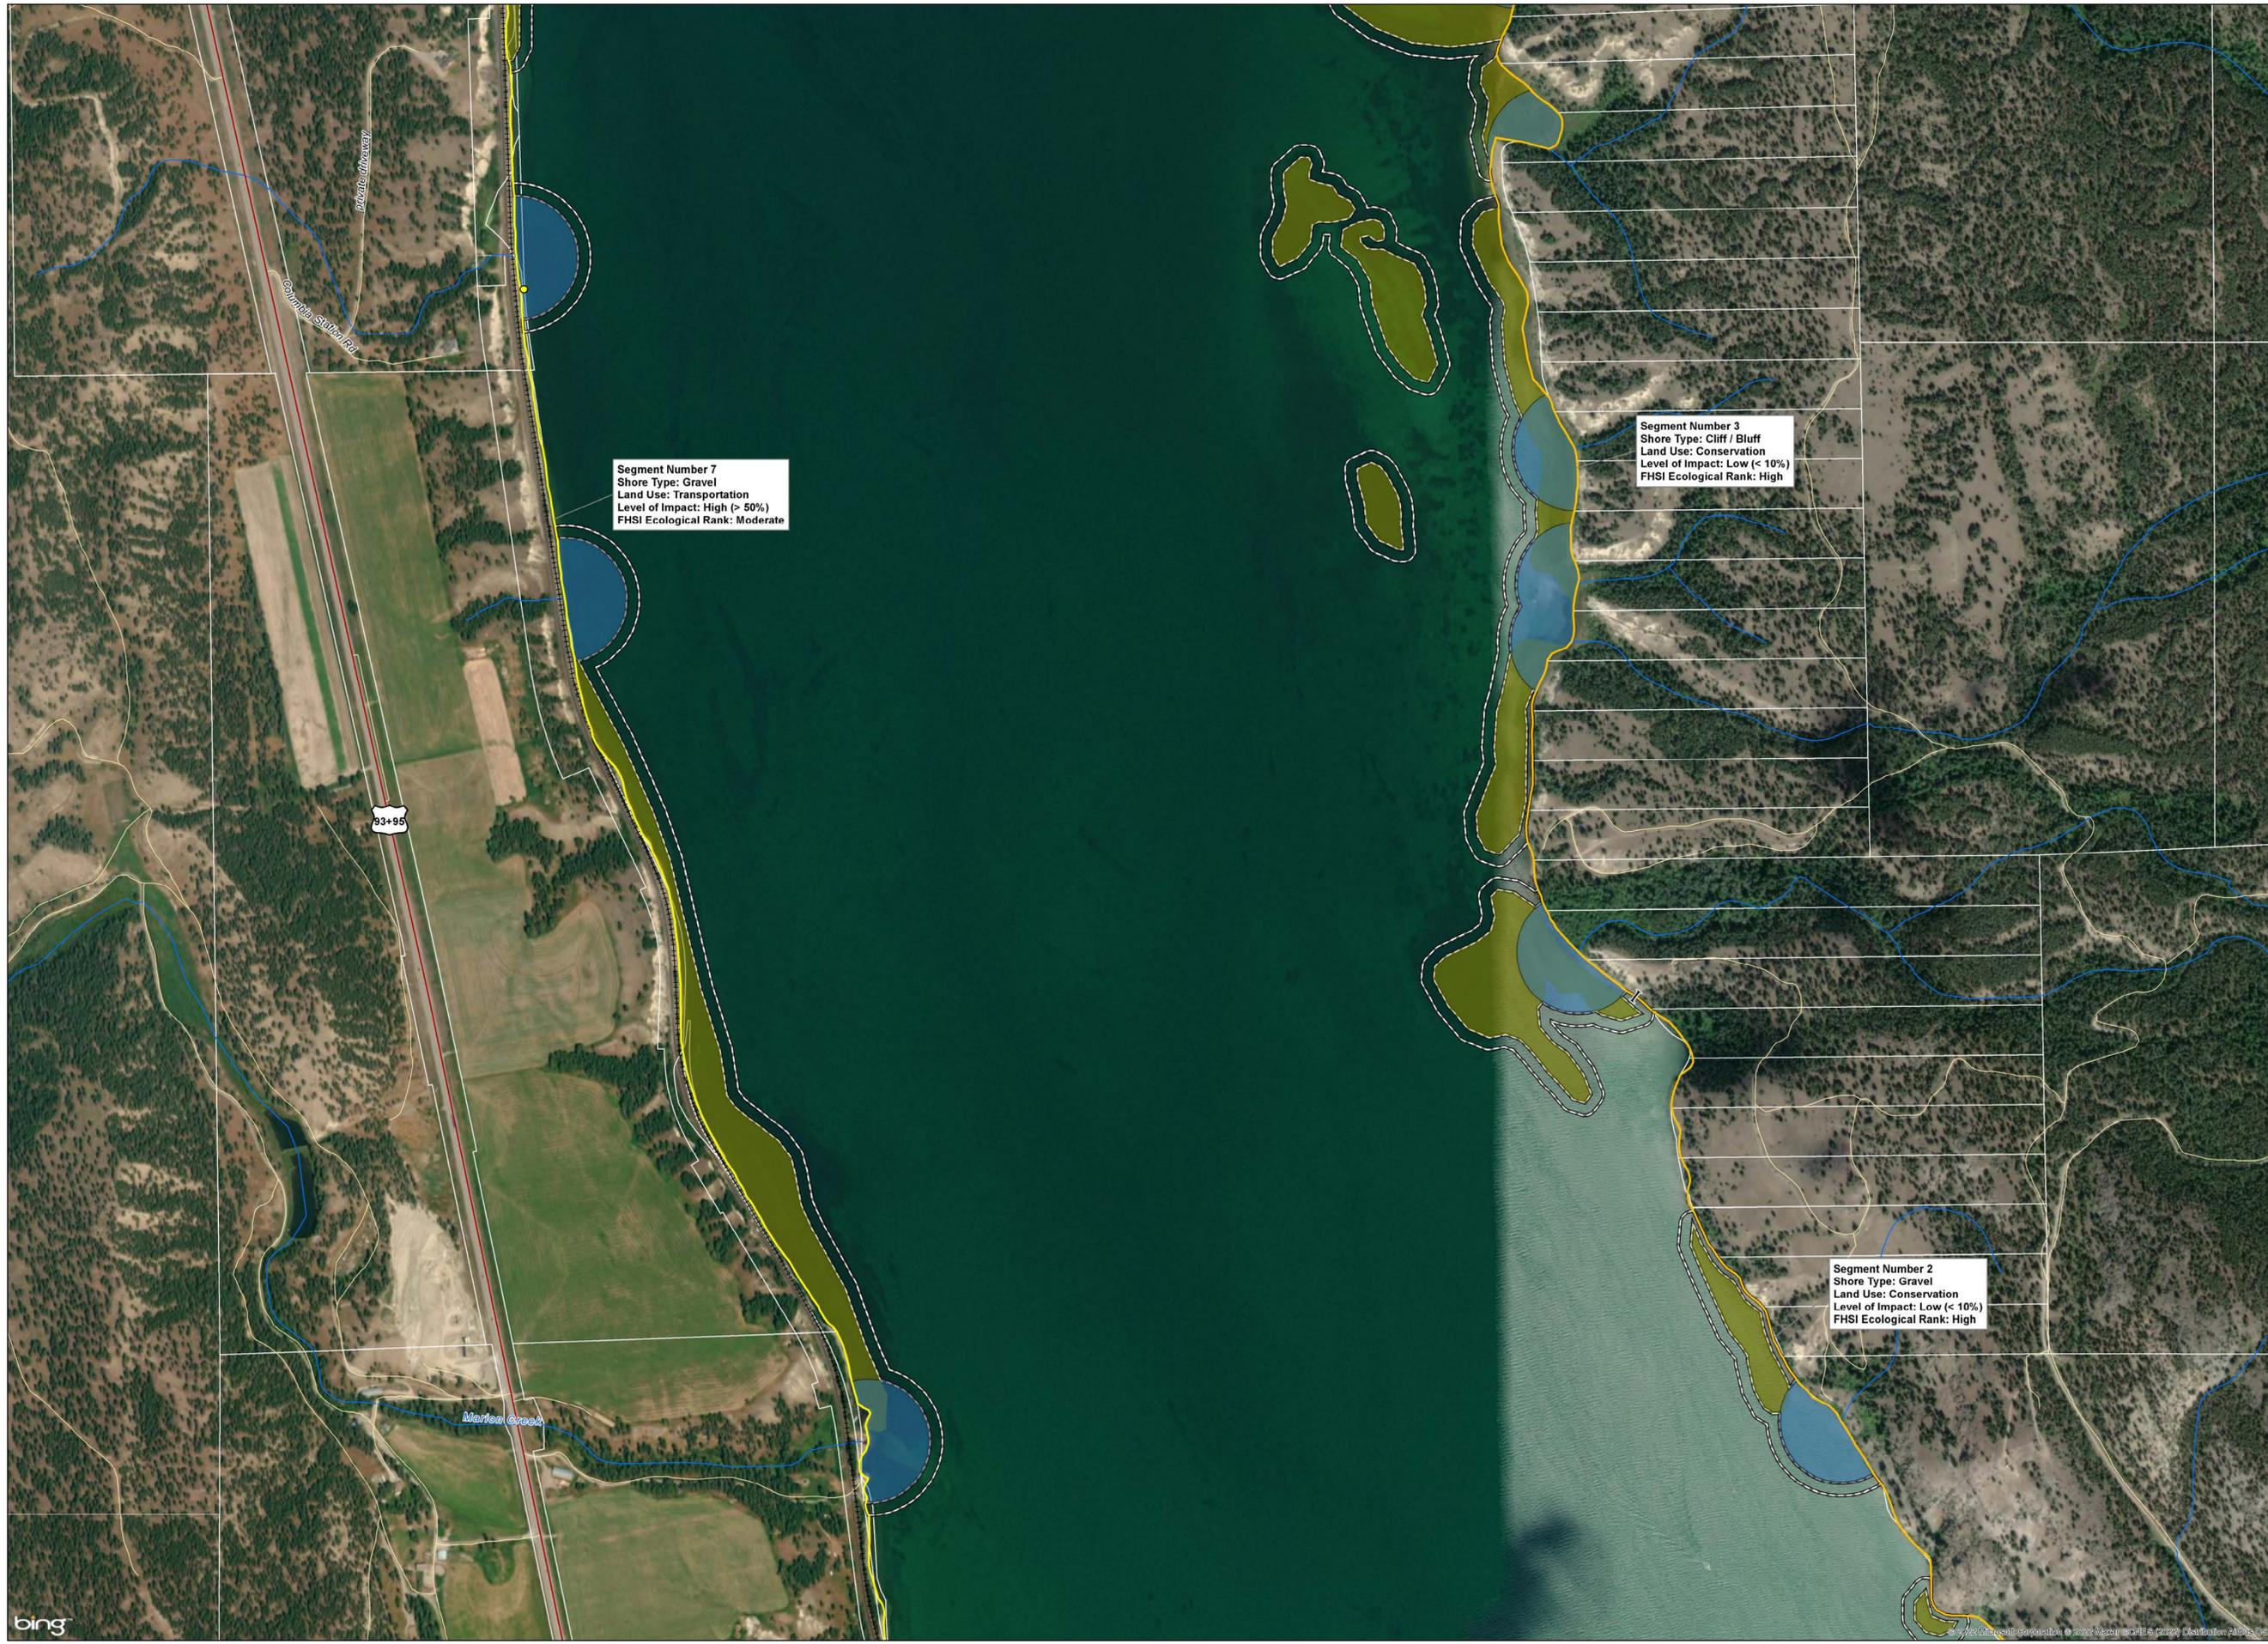
Segment Number 7
 Shore Type: Gravel
 Land Use: Transportation
 Level of Impact: High (> 50%)
 FHSI Ecological Rank: Moderate

Segment Number 3
 Shore Type: Cliff / Bluff
 Land Use: Conservation
 Level of Impact: Low (< 10%)
 FHSI Ecological Rank: High

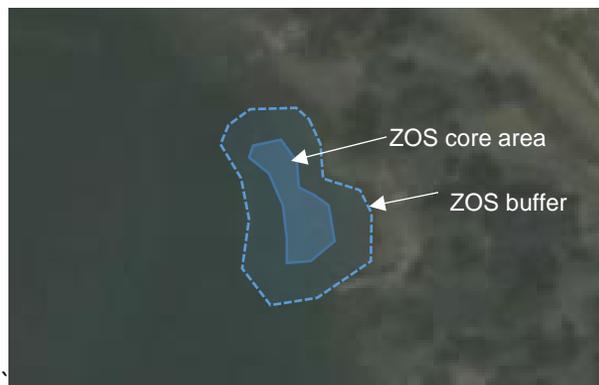
Figure 2. Zone of Sensitivity with an appropriate buffer.

The FDG map also depicts each ZOS in a specific colour scheme. Each ZOS is presented as either a polygon, line, or point, and should include an outer buffer. This buffer accounts for unknowns of the ZOS full extent and protects the core ZOS from potential impacts from adjacent activities (Figure 2). Details on each ZOS, including how each was defined, and how the buffers were determined are presented in Section 5.2.
